## **Parramatta City Council Newington Street Tree Mapping Project Newington NSW**

## ArborSite - Tree Assessment Report summary for Newington Street Trees

Date Assessment Commenced: June 20th, 2017

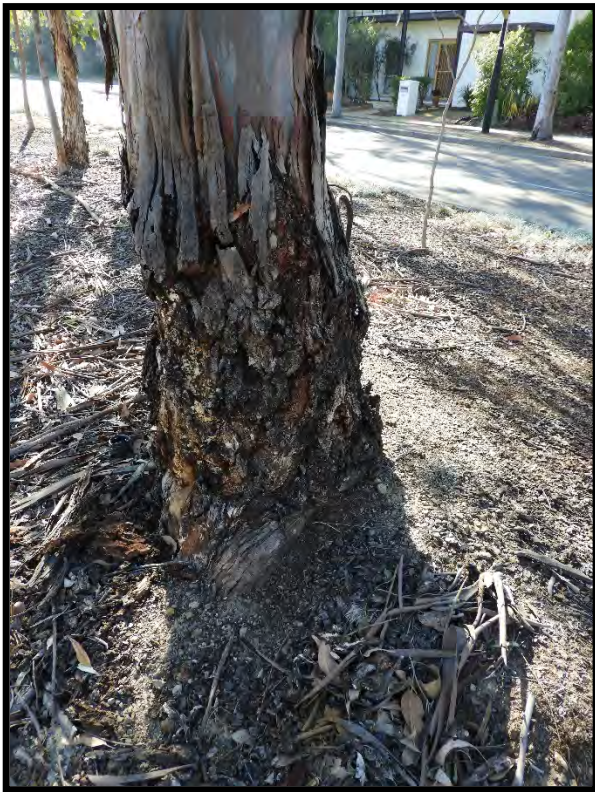
An example of *Eucalyptus saligna* with significant basal borer damage that the tree is unable to compensate for. This tree is also an example of a Priority 3.

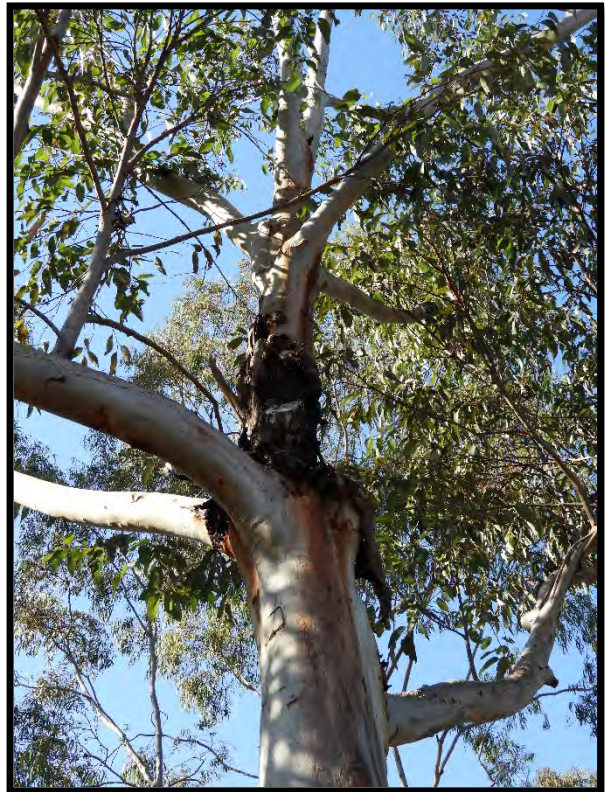
An example of *Eucalyptus saligna* with significant borer damage in the upper canopy that has resulted in a tree of poor structure that the tree is unable to compensate for. This tree is also an example of a Priority 3.

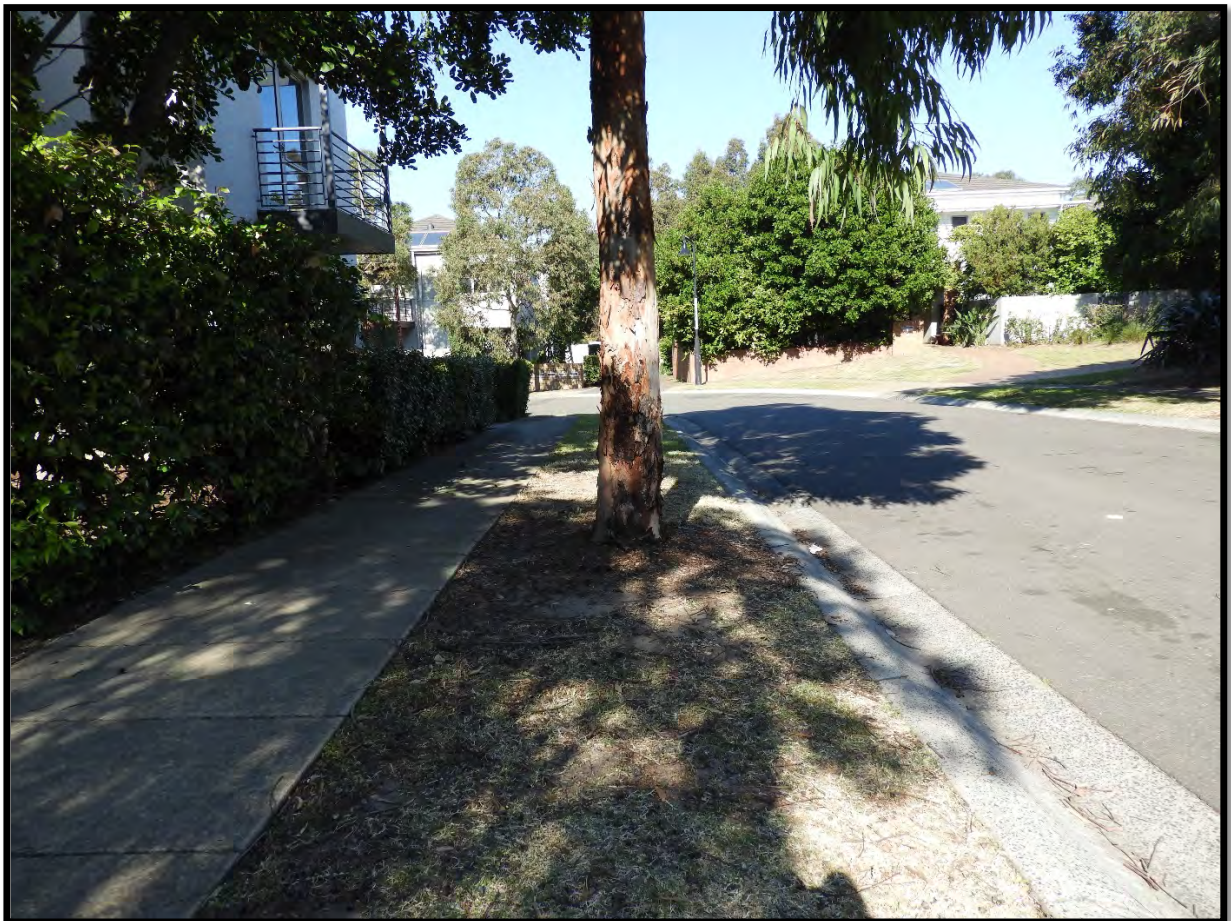
An example of tree planted at appropriate depth. This is also an example of a Priority 5 tree.

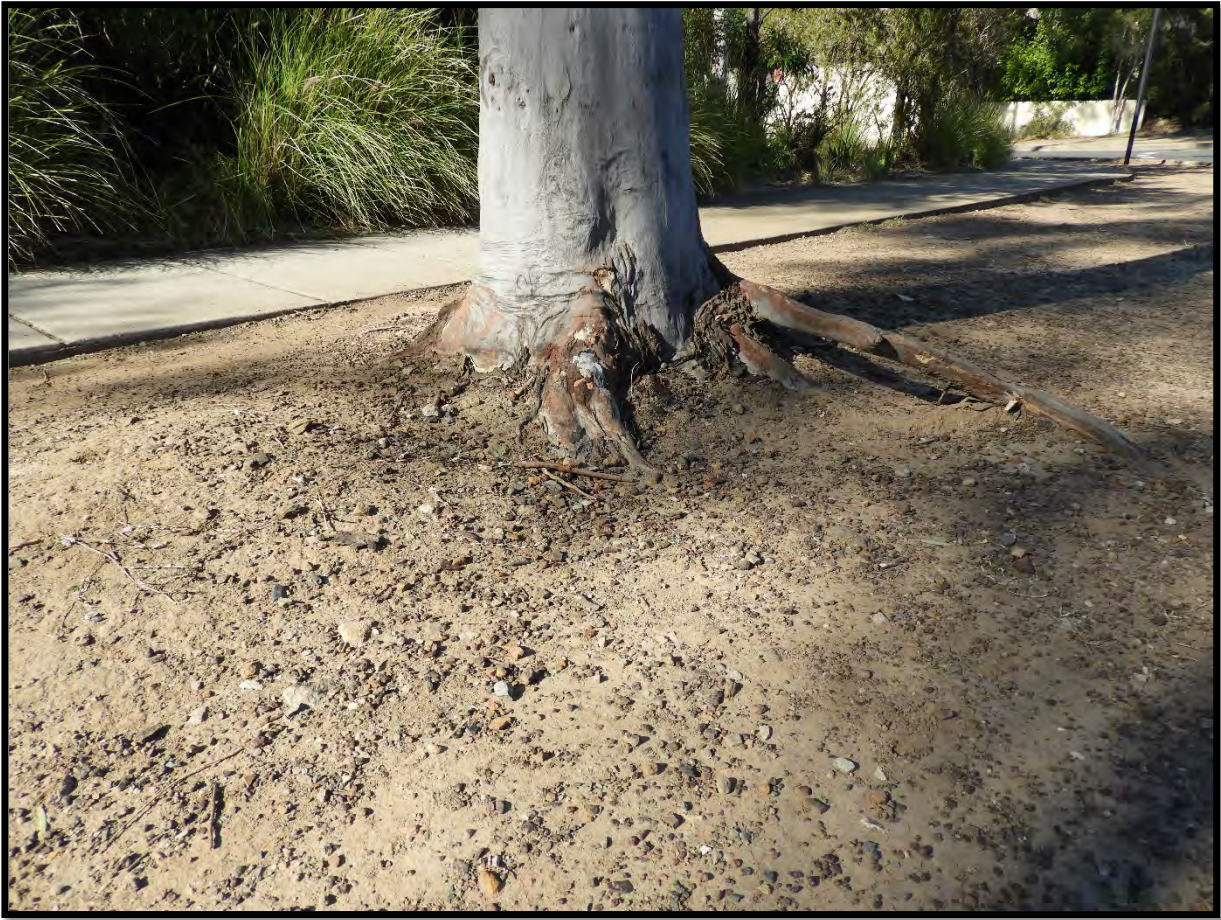
An example of tree planted too shallow. This is also an example of a Priority 4 tree as the footpath has already been replaced.

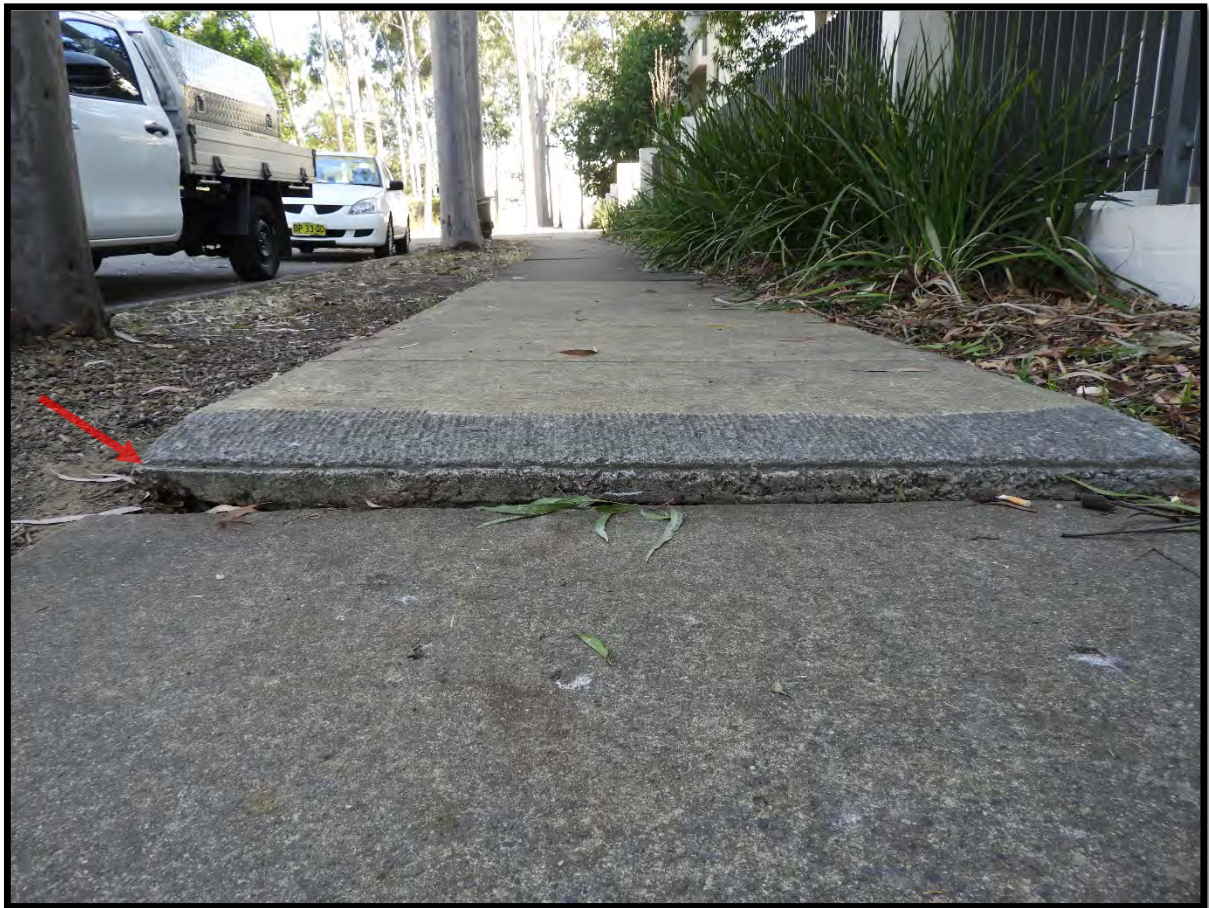
An example of significant foot path displacement. This is also an example of a Priority 2 Tree as repairs to the footpath will likely cause significant damage to the tree's structural root system.

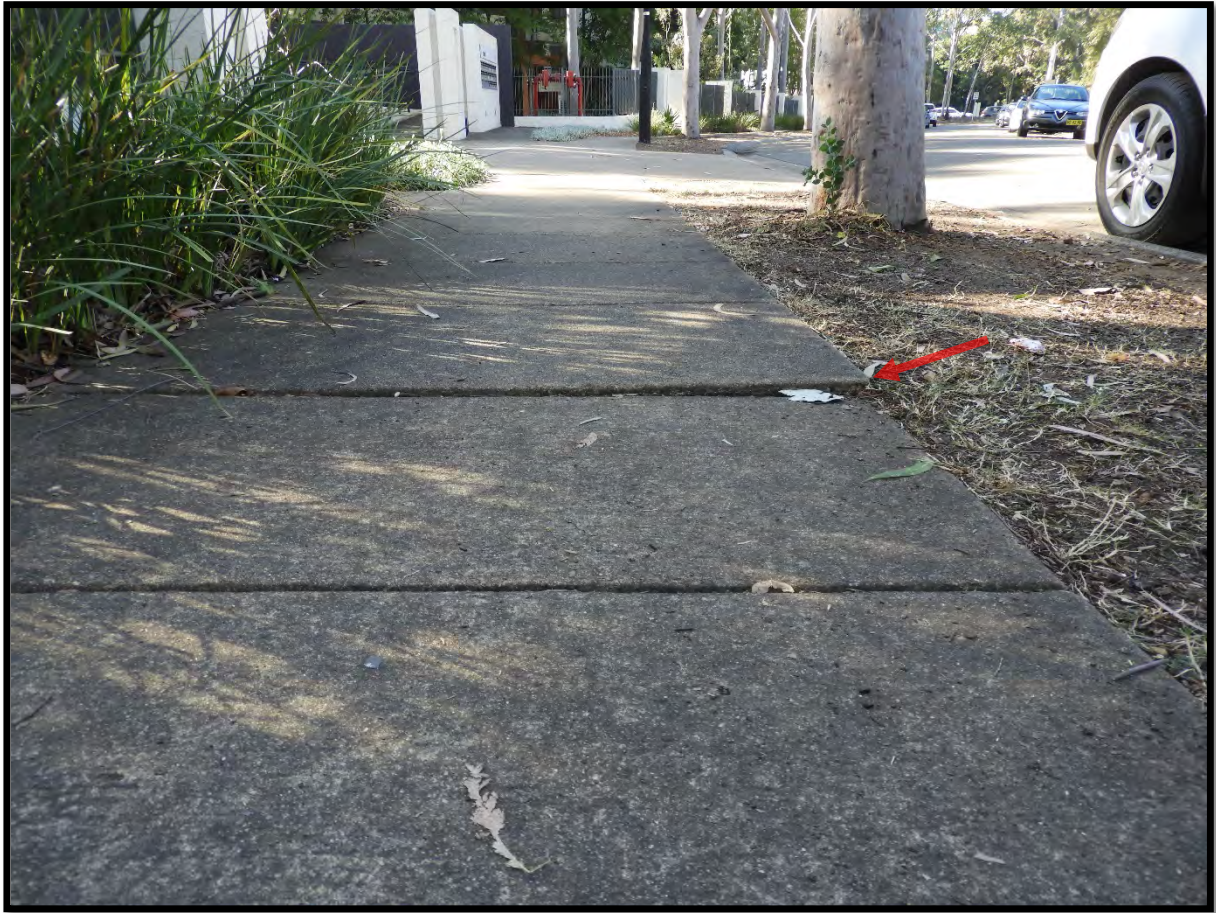
An example of minor footpath displacement. This is also an example of a Priority 4 Tree.

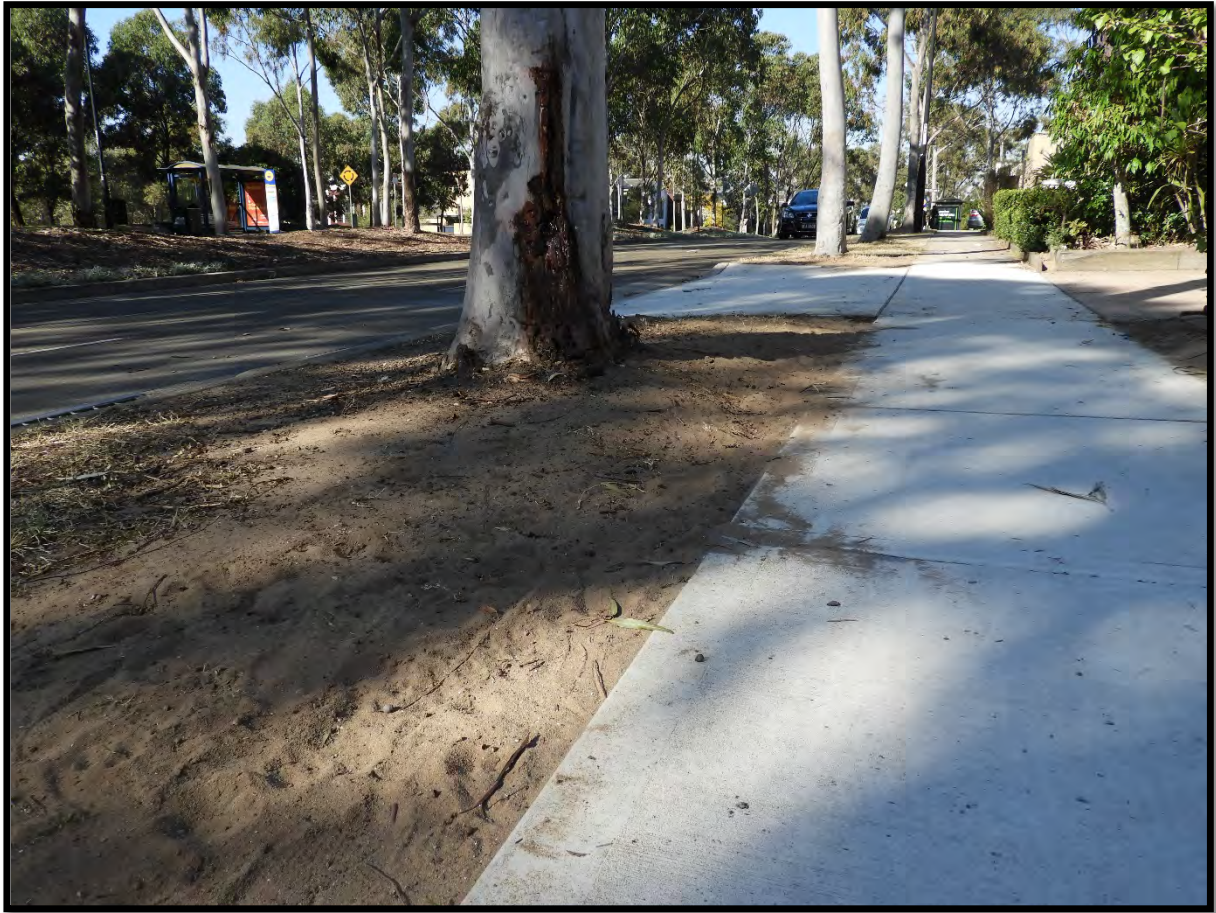
An example of both tree being planted too shallow and newly installed footpath.  
The construction of the footpath appears to only have regular expansion joints and no Tripstop.

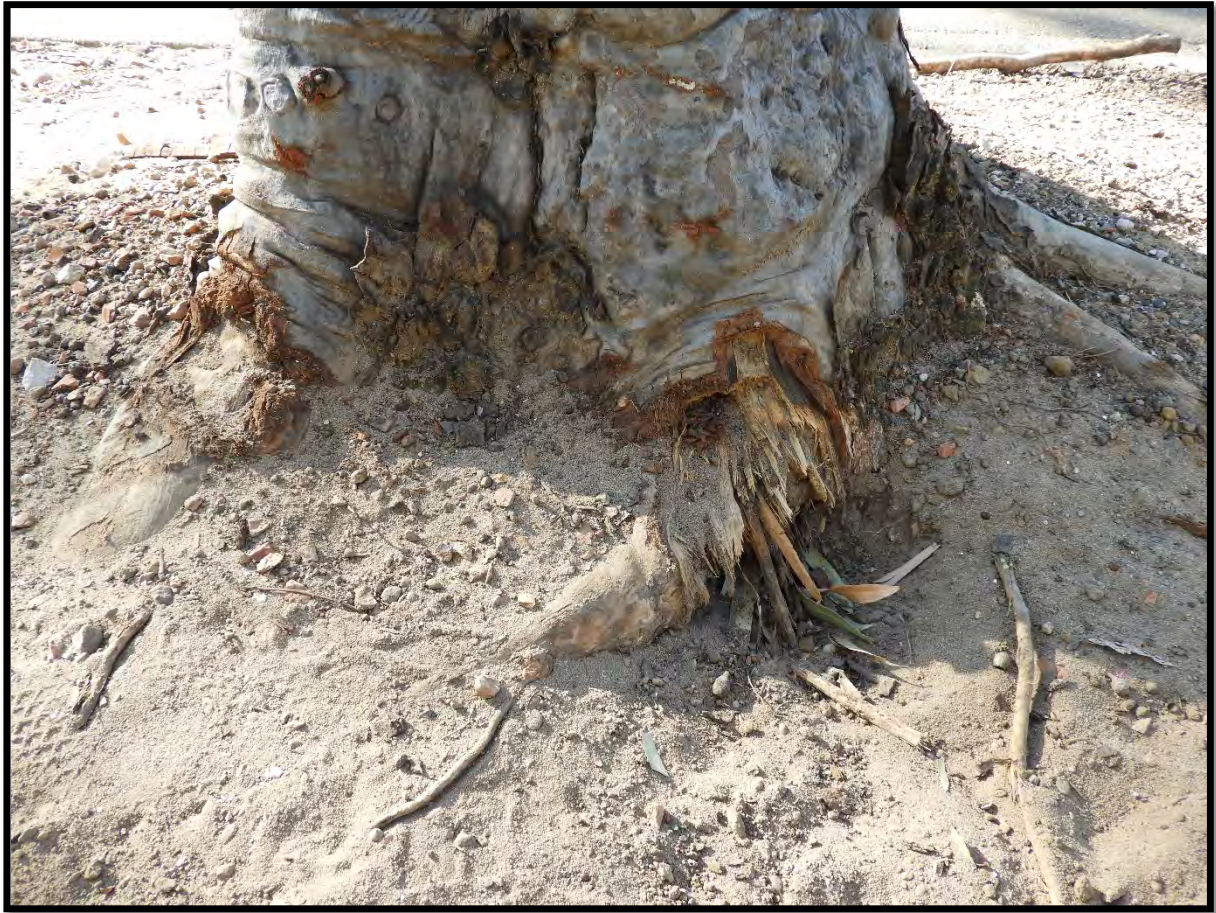
An example of damage that has occurred to the structural root system of the tree during recent footpath reinstatement. This tree is listed as a High-Risk tree due to the unknown damage that has occurred to the structural root system. This is also a Priority 2 Tree.
