Toongabbie Creek Waterways Maintenance and Rehabilitation Masterplan

**UPPER TOONGABBIE CREEK:  
CREEK MAINTENANCE AND  
REHABILITATION MASTERPLAN**

**VOLUME 1**

**Issue No. 2  
AUGUST 2002**

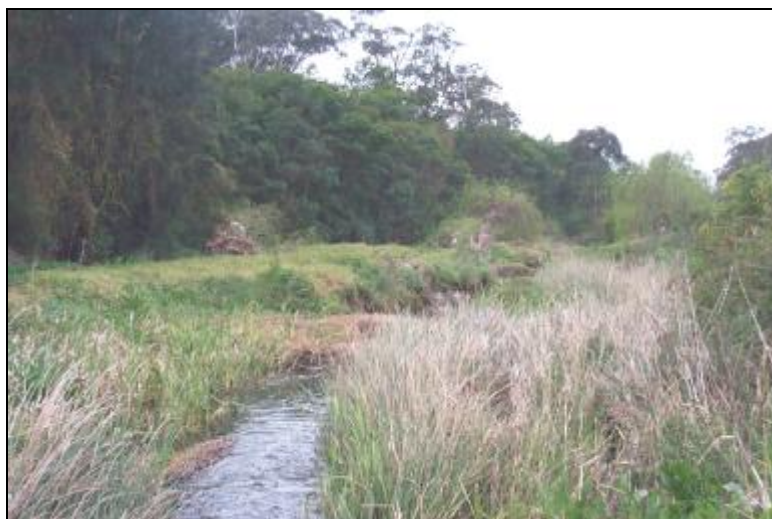
**Map 1** An instream sediment deposition zone has developed over time, since construction of the channelised reach, due to an oversupply of catchment sediments available at the upstream end of the waterway corridor. Much of the in-channel sediment bars have prograded into the channel from the lower left bank alignment, and have been densely colonised with Alligator Weed (see **Plate 1**).

**Plate 1 Example of Sediment Deposition Zone**

Mechanical removal of the in-channel sediments (*in the case of Toongabbie Creek through the use of either land based or in-channel excavator*) is problematic and is likely to contribute to further downstream spread (*NSW Agriculture*).

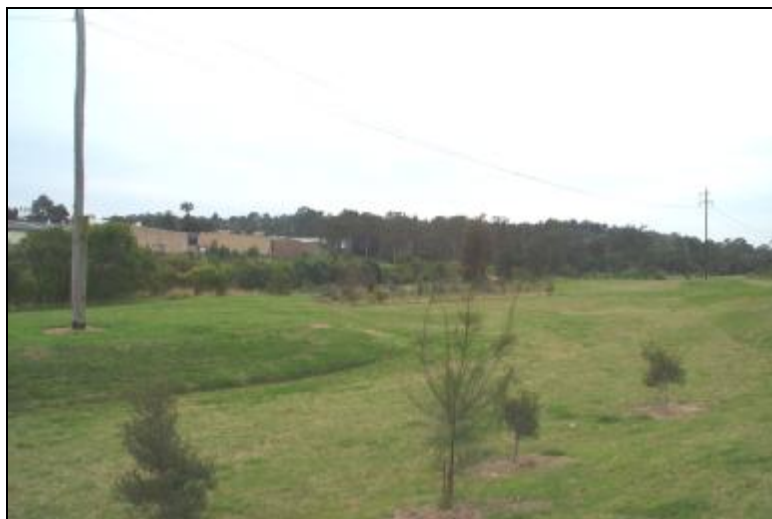
**Plate 2 Site of Historical Meander in Photo Mid-Ground**

In order to divert flows from the main channel into the restored meander, a diversion weir would be required to be formed across the bed of main channel. Such a weir would affect normal flow behaviour in the channel. It was also considered that such a weir would act to direct suspended sediments to the meander entrance subsequently reducing the effectiveness of the meander through deposition.

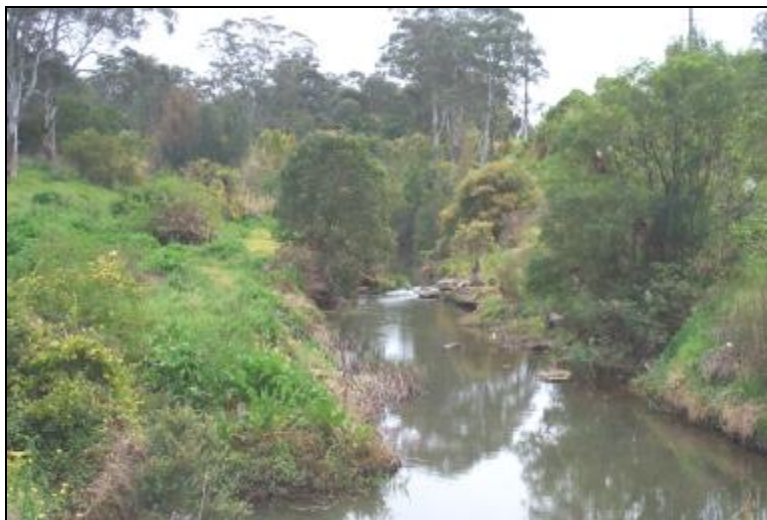
**Plate 3 Stream Form adjacent to Riffle Site.**  
A Natural Riffle occurs in the photo centre ground.

The riffle structure itself, designed to be formed in a “vee” shape to centralise low flows immediately upstream of the bank protection constructed for the Old Windsor Road bridge works, is also located immediately upstream of the limits of influence of the flows impounded behind the concrete encased water main located downstream at river chainage 8832 (*approximately*). The structure is expected to provide positive benefits in water quality through aeration, provide additional varietal aquatic habitat and is considered unlikely to restrict fish migration.

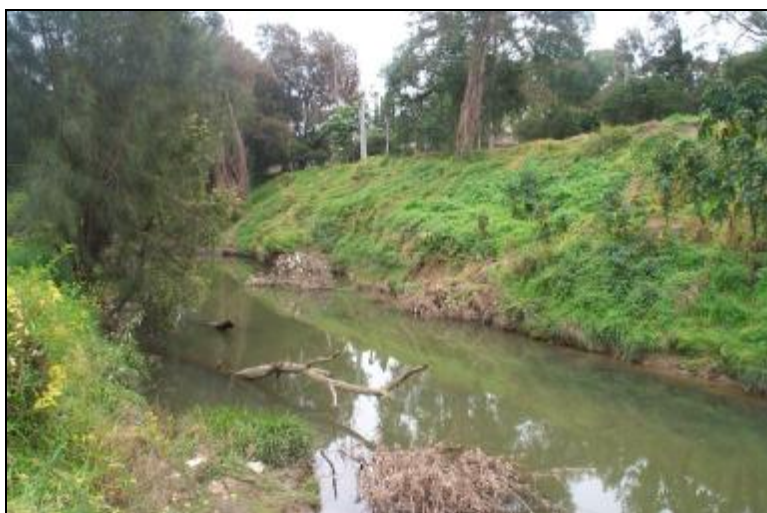
The lower bank is experiencing erosion consistent with toe failure. Concave slumping is evident, and it is considered that structural management is required in order to protect road and allied infrastructure (see **Plate 4**). The proposed structure, recommended as a placed rock (*sandstone, preferably*) wall, founded on a gabion (*rock filled rectangular cage*) toe. The gabion row is proposed to be placed below anticipated bed scour depth.

**Plate 4 Concave Bank Slumping at Site of Proposed Bank Protection Works**

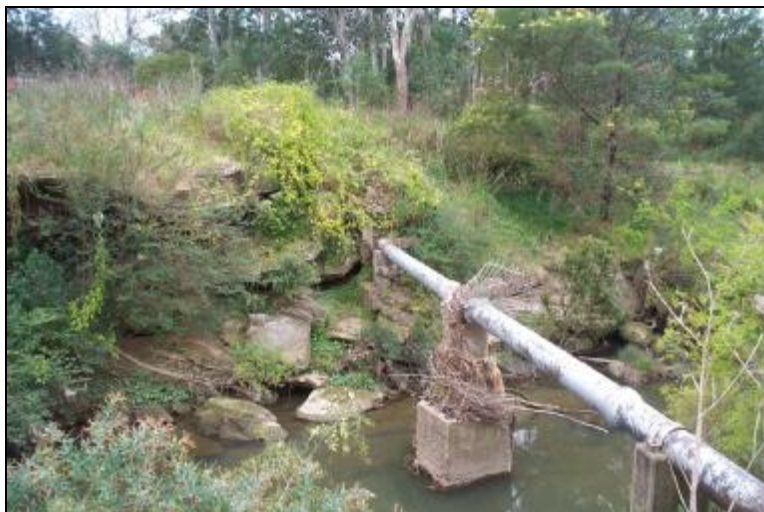
As described, the sewer aqueduct is supported at the banks on concrete piers, and is supported centrally with another, in-channel, concrete pier (see **Plate 5**). The central support may contribute to circular flow patterns which may in turn induce bank erosion. Although not located where flood levels are critical to adjacent property flood liability, the pier may cause channel blockages through trapped debris, modifying flow behaviour.

**Plate 5 Site of Sewer Aqueduct**

| Masterplan Activity | Location |
|---|---|
| Consider reduction of debris trapping and erosive flow behaviour at elevated sewer aquaduct<br>Investigate design/construction modification for removal if in-stream central supporting pier<br>Investigate provision of rock bank protection to protect infrastructure failure<br>Periodic inspection: every three (3) months<br>Episodic inspection: after each bank full flood event<br>Activity trigger: structural damage; trapped debris; concave bank retreat upstream and downstream or structural terminals | Map 8<br>Ch 9825 |
