Review of Environmental Factors

BORONIA PARK -NEW SPORTS PAVILION, EPPING

Prepared by: Think Planners Pty Ltd Document Date: 24 July 2020

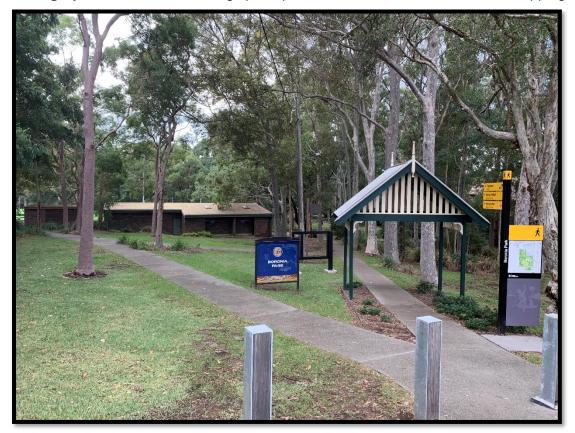
Photograph 1: Shows the existing sports pavilion as viewed from Kent Street, Epping.

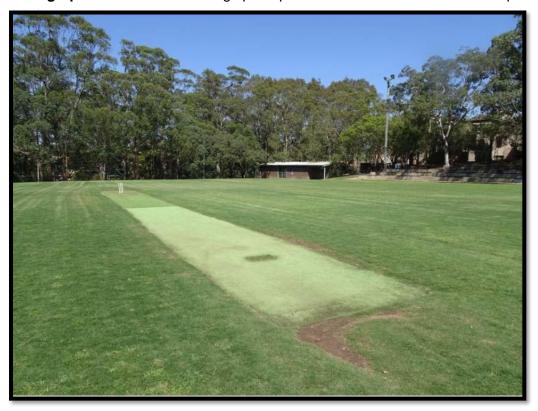
Photograph 2: Shows the existing sports pavilion as viewed from the cricket pitch.

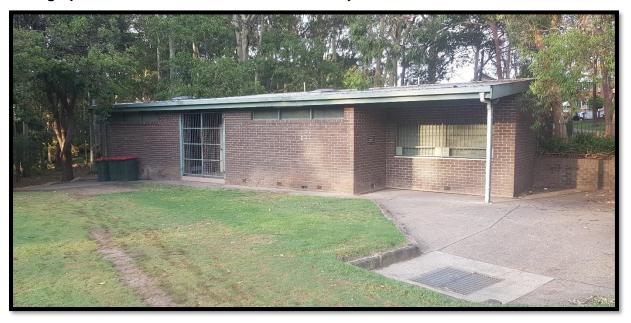
Photograph 3: Shows a view of the rear of the facility to be demolished.

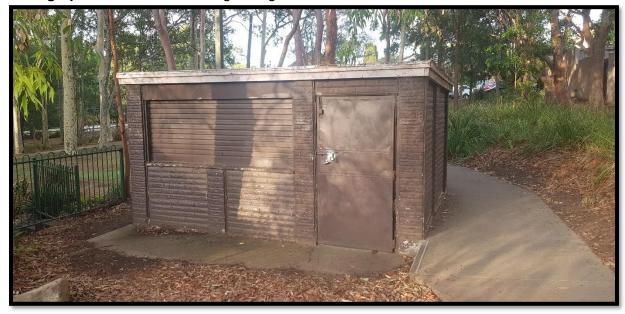
Photograph 4: Shows the existing storage shed to be demolished.

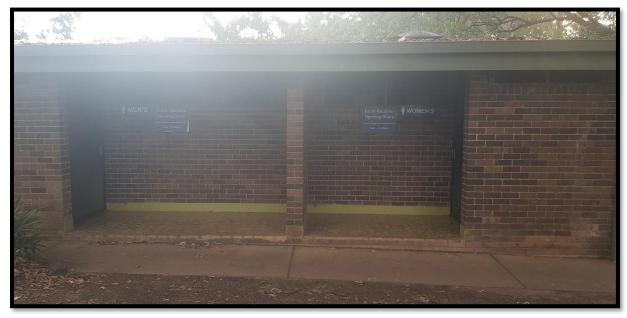
Photograph 5: Shows the existing public toilets within the sports pavilion that faces Kent Street, Epping.

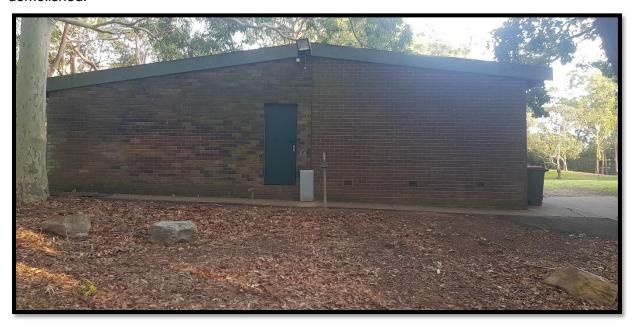
Photograph 6: Shows the southern elevation of the existing sports pavilion that is to be demolished.

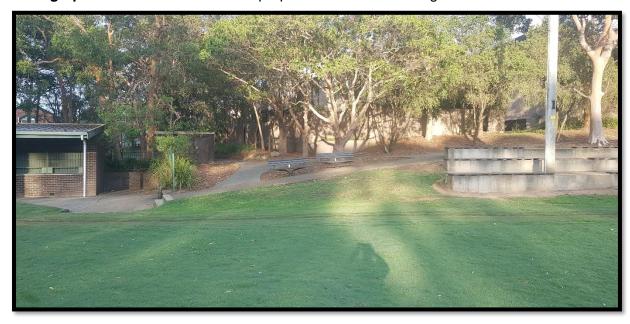
Photograph 7: Shows the area of the proposed additional seating.

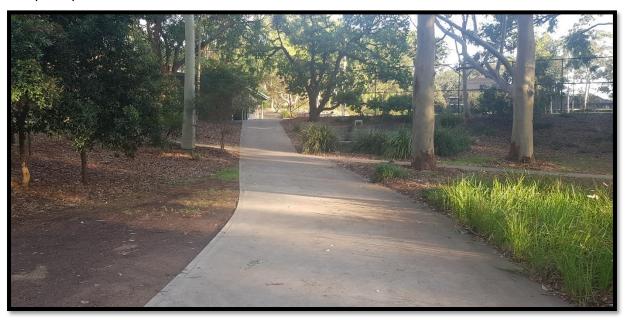
Photograph 10: Shows the view of the existing maintenance vehicular access driveway to the sports pavilion.

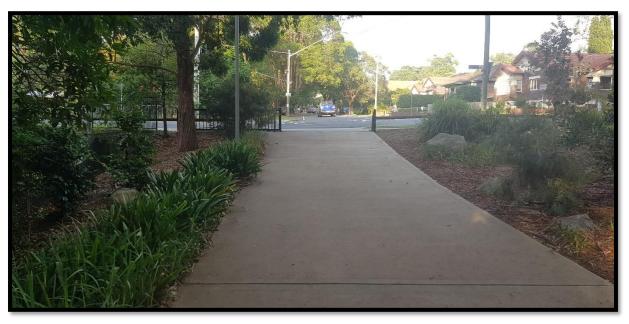
Photograph 11: Shows the view of the existing maintenance vehicular access driveway cross over from Kent Street, Epping.

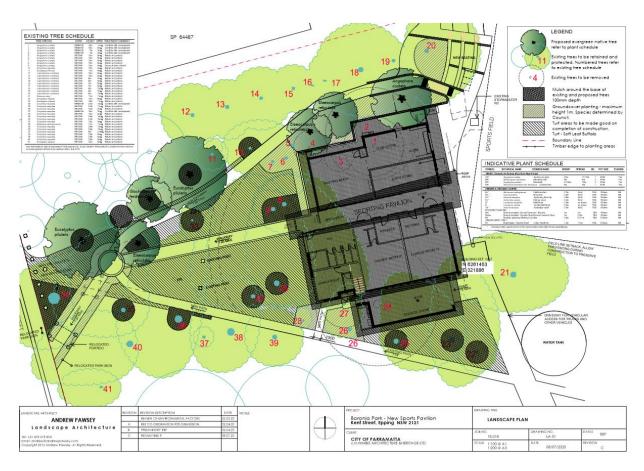
Figure 2 - Landscaping plan showing the proposed building and associated works (northern proposed building) – (Source: Andrew Pawsey Landscape Architecture)

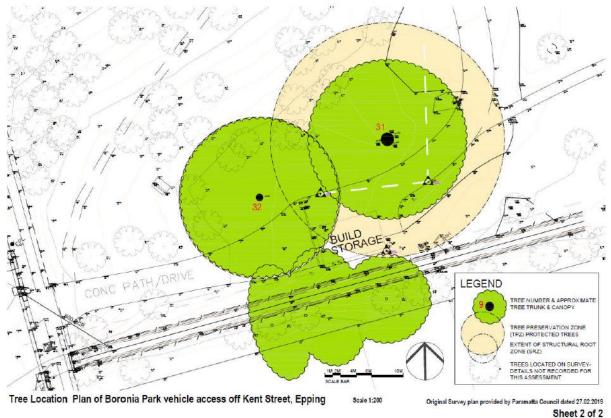
Figure 3 - Tree locations around the proposed storage shed (southern proposed building) –

(Source: Draft Arboriculture Impact Assessment – Susan Stratton)

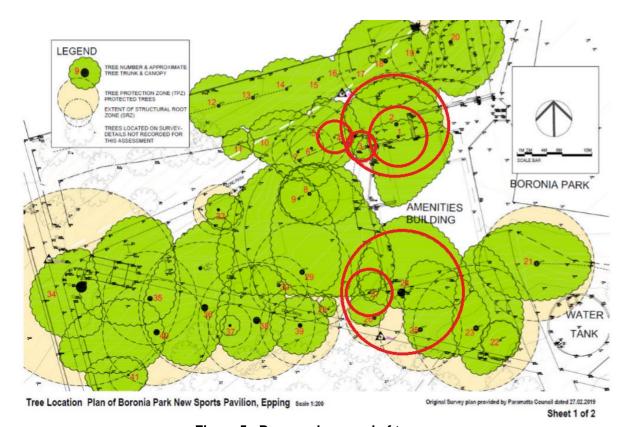
Figure 5 - Proposed removal of trees (Source: Draft Arboriculture Impact Assessment – Susan Stratton)

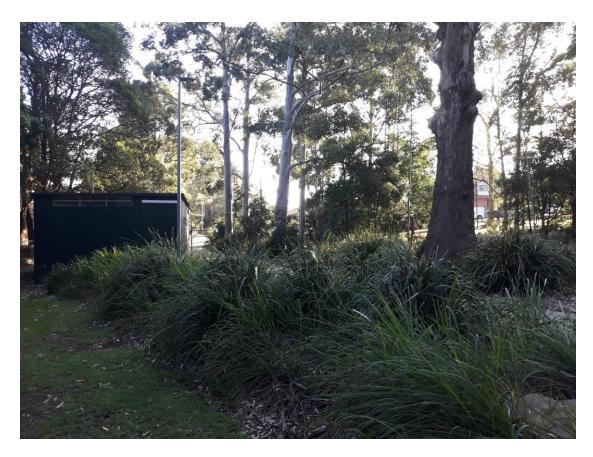
Photo 4 - Existing storage building and remnant Blue Gums

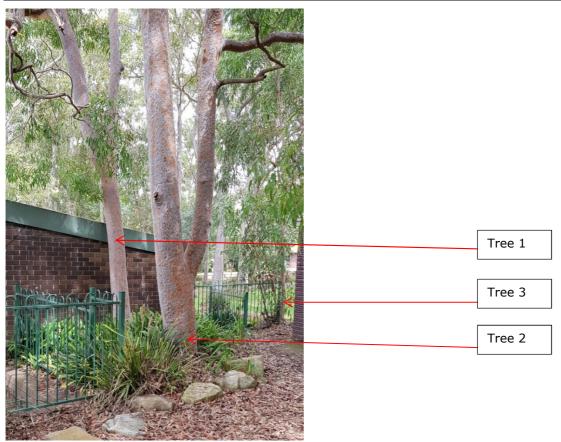
Figure 4 Trees 1, 2 and 3 *Angophora costata* will have to be removed to accommodate the new building footprint. Photo taken by Author 22nd March 2019,

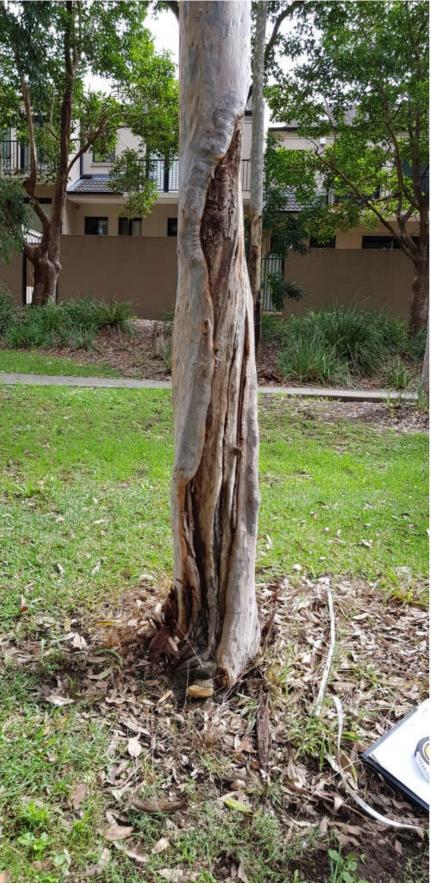
Figure 6 Tree 9 *Angophora costata* will require further assessment to determine the extent of decay and the potential for failure. Longitudinal cracks are a concern given that the occlusion of the wound will take at least 2 more growing seasons. Photo taken by Author 22nd March 2019

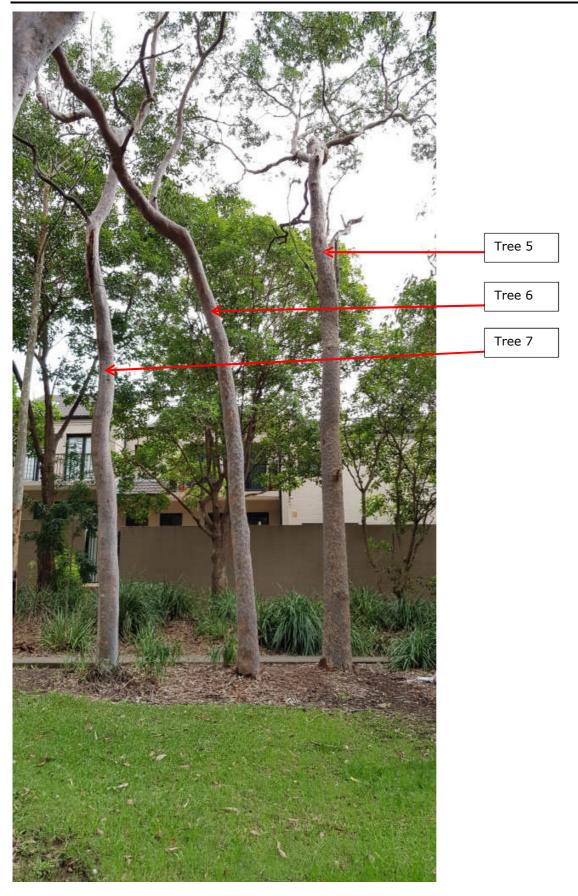
Figure 7 Trees 5, 6 and 7 are all *Angophora costata* are to be retained. These trees have been regularly trimmed away from overhead wires and as a result have poor form. Deadwood requires removal in particular that overhanging the path. Photo taken by Author 22nd March 2019

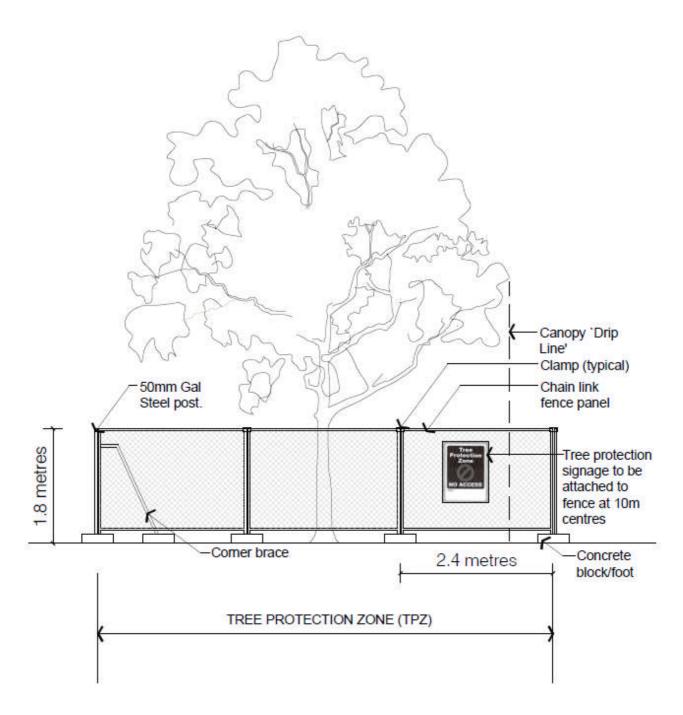
Illustration 1 Tree Protection Fence detail. Source – AS 4970-2009 Protection of trees on development sites, p16

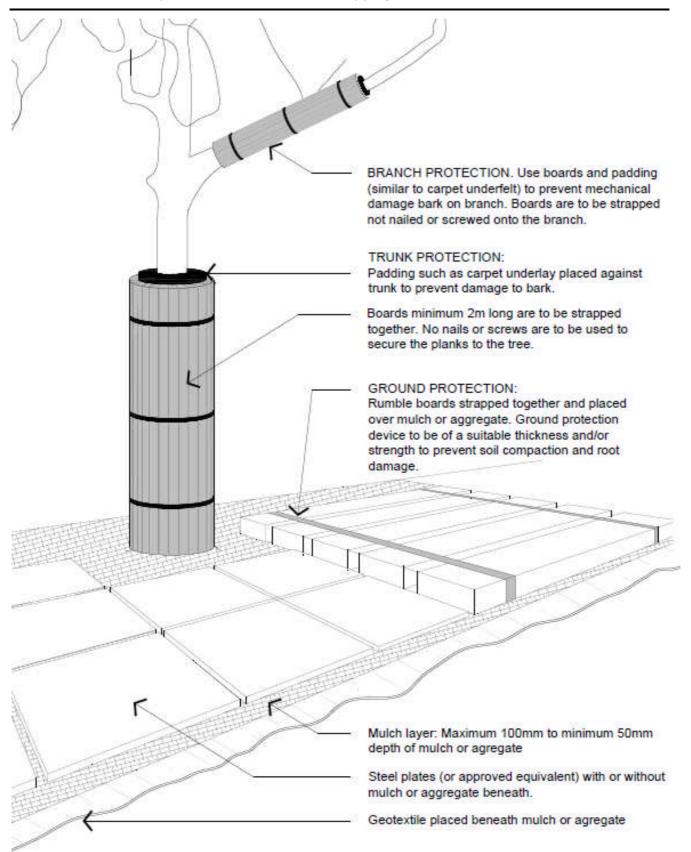
Illustration 2 Tree Trunk and Tree protection. Source AS 4970-2009 Protection of trees on development sites. This form of protection will be required during construction.

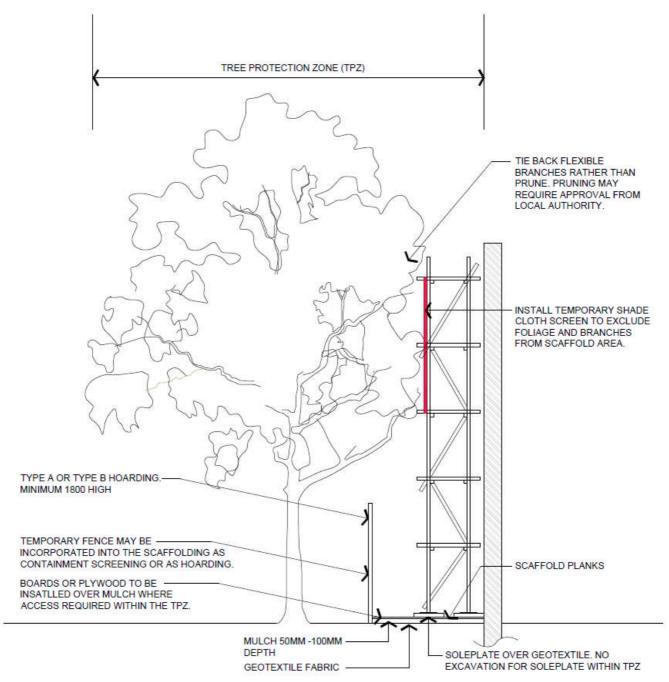
Illustration 3: Detail of Temporary Scaffolding within the Tree Protection Zone

NOTE: NO ROOTS GREATER THAN 20MM DIAMETER ARE TO BE SEVERED DURING EXCAVATION FOR INSERTION OF SUPPORT POSTS FOR THE TREE PROTECTION FENCING WITHOUT THE PRIOR APPROVAL OF THE PROJECT ARBORIST.

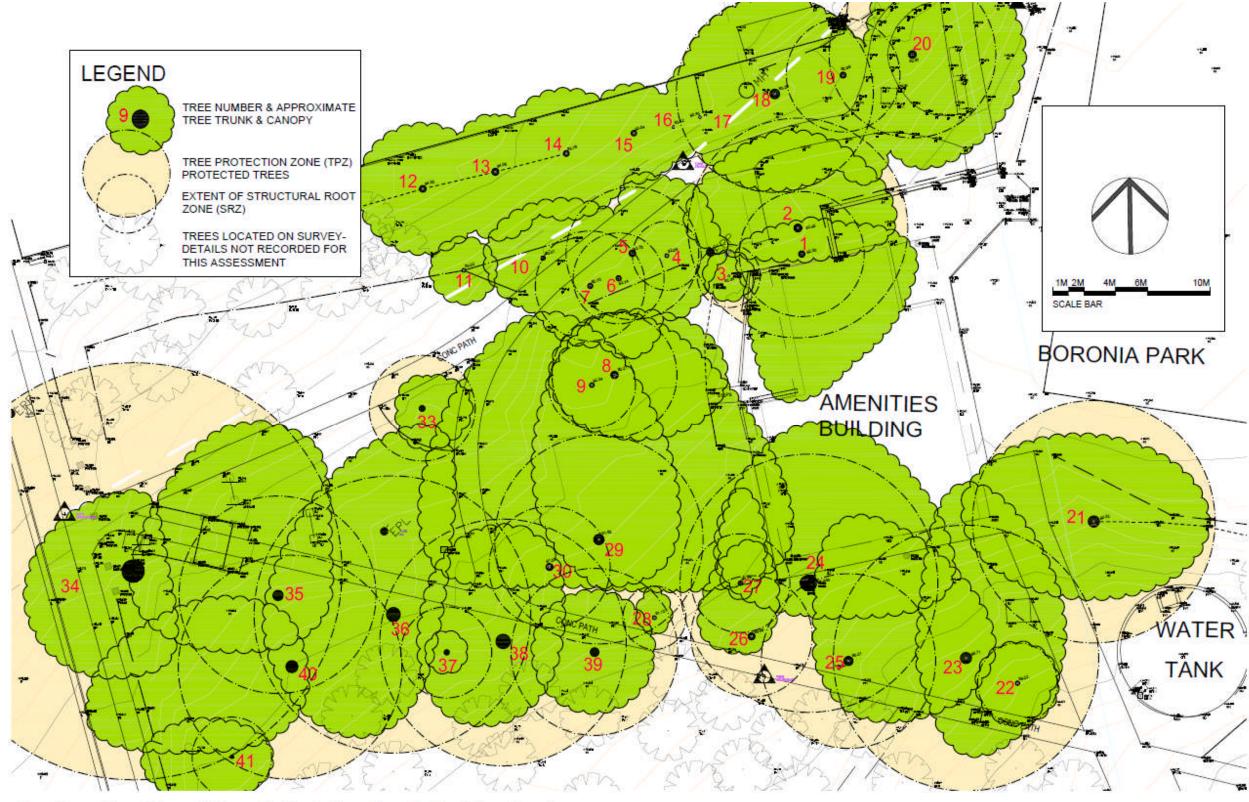
Tree Location Plan of Boronia Park New Sports Pavilion, Epping Scale 1:200

TPZ indicated is that required by AS 4970-2009 Protection of trees on development sites. Actual dimensions can be found in **Appendix A**

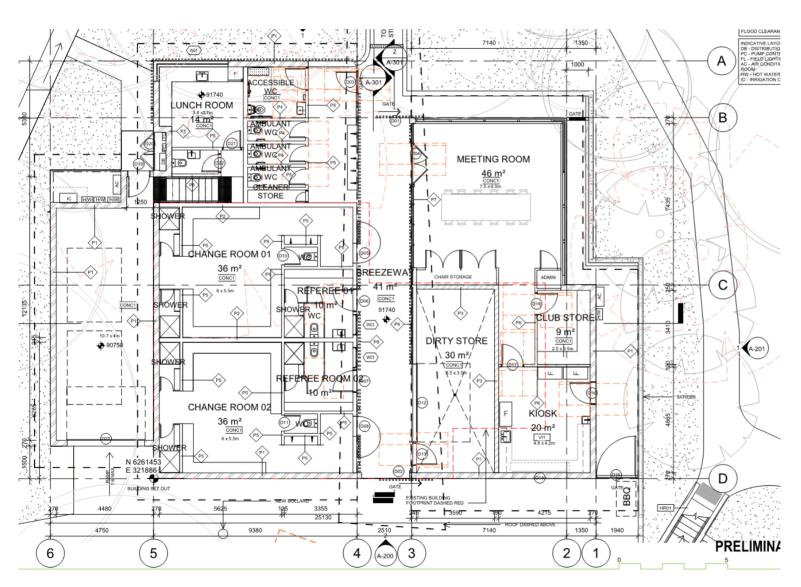
The proposed ground floor plan is indicated below;
