QUARRY BRANCH CREEK: MAINTENANCE & REHABILITATION MASTER PLAN

VOLUME 2 Main Report

Issue No. 1

November 2005

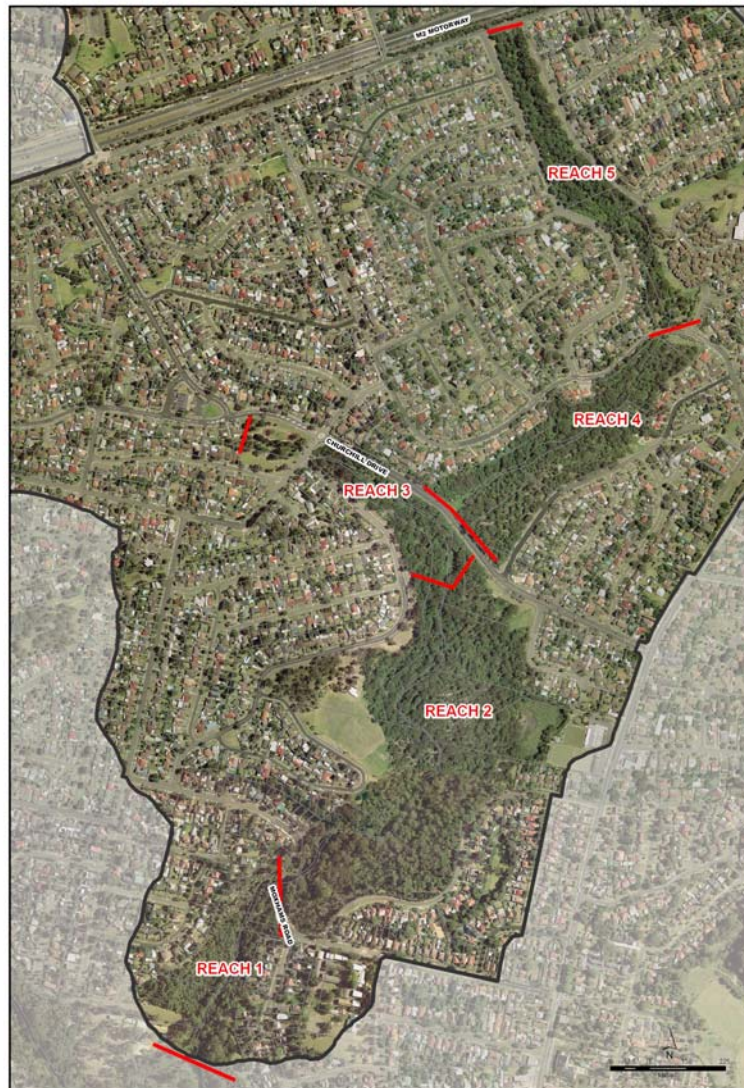
Map 3 - Management reaches

Reach	Location	Length	Average corridor width
1	Toongabbie Creek Confluence to Moxhams Road	415m	125m
2	Moxhams Road to Churchill Drive	960m	130m
3	Tributary confluence to Willmott Avenue	350m	65m
4	Churchill Drive to Model Farms Road	580m	146m
5	Model Farms Road to Junction Road	690m	45m

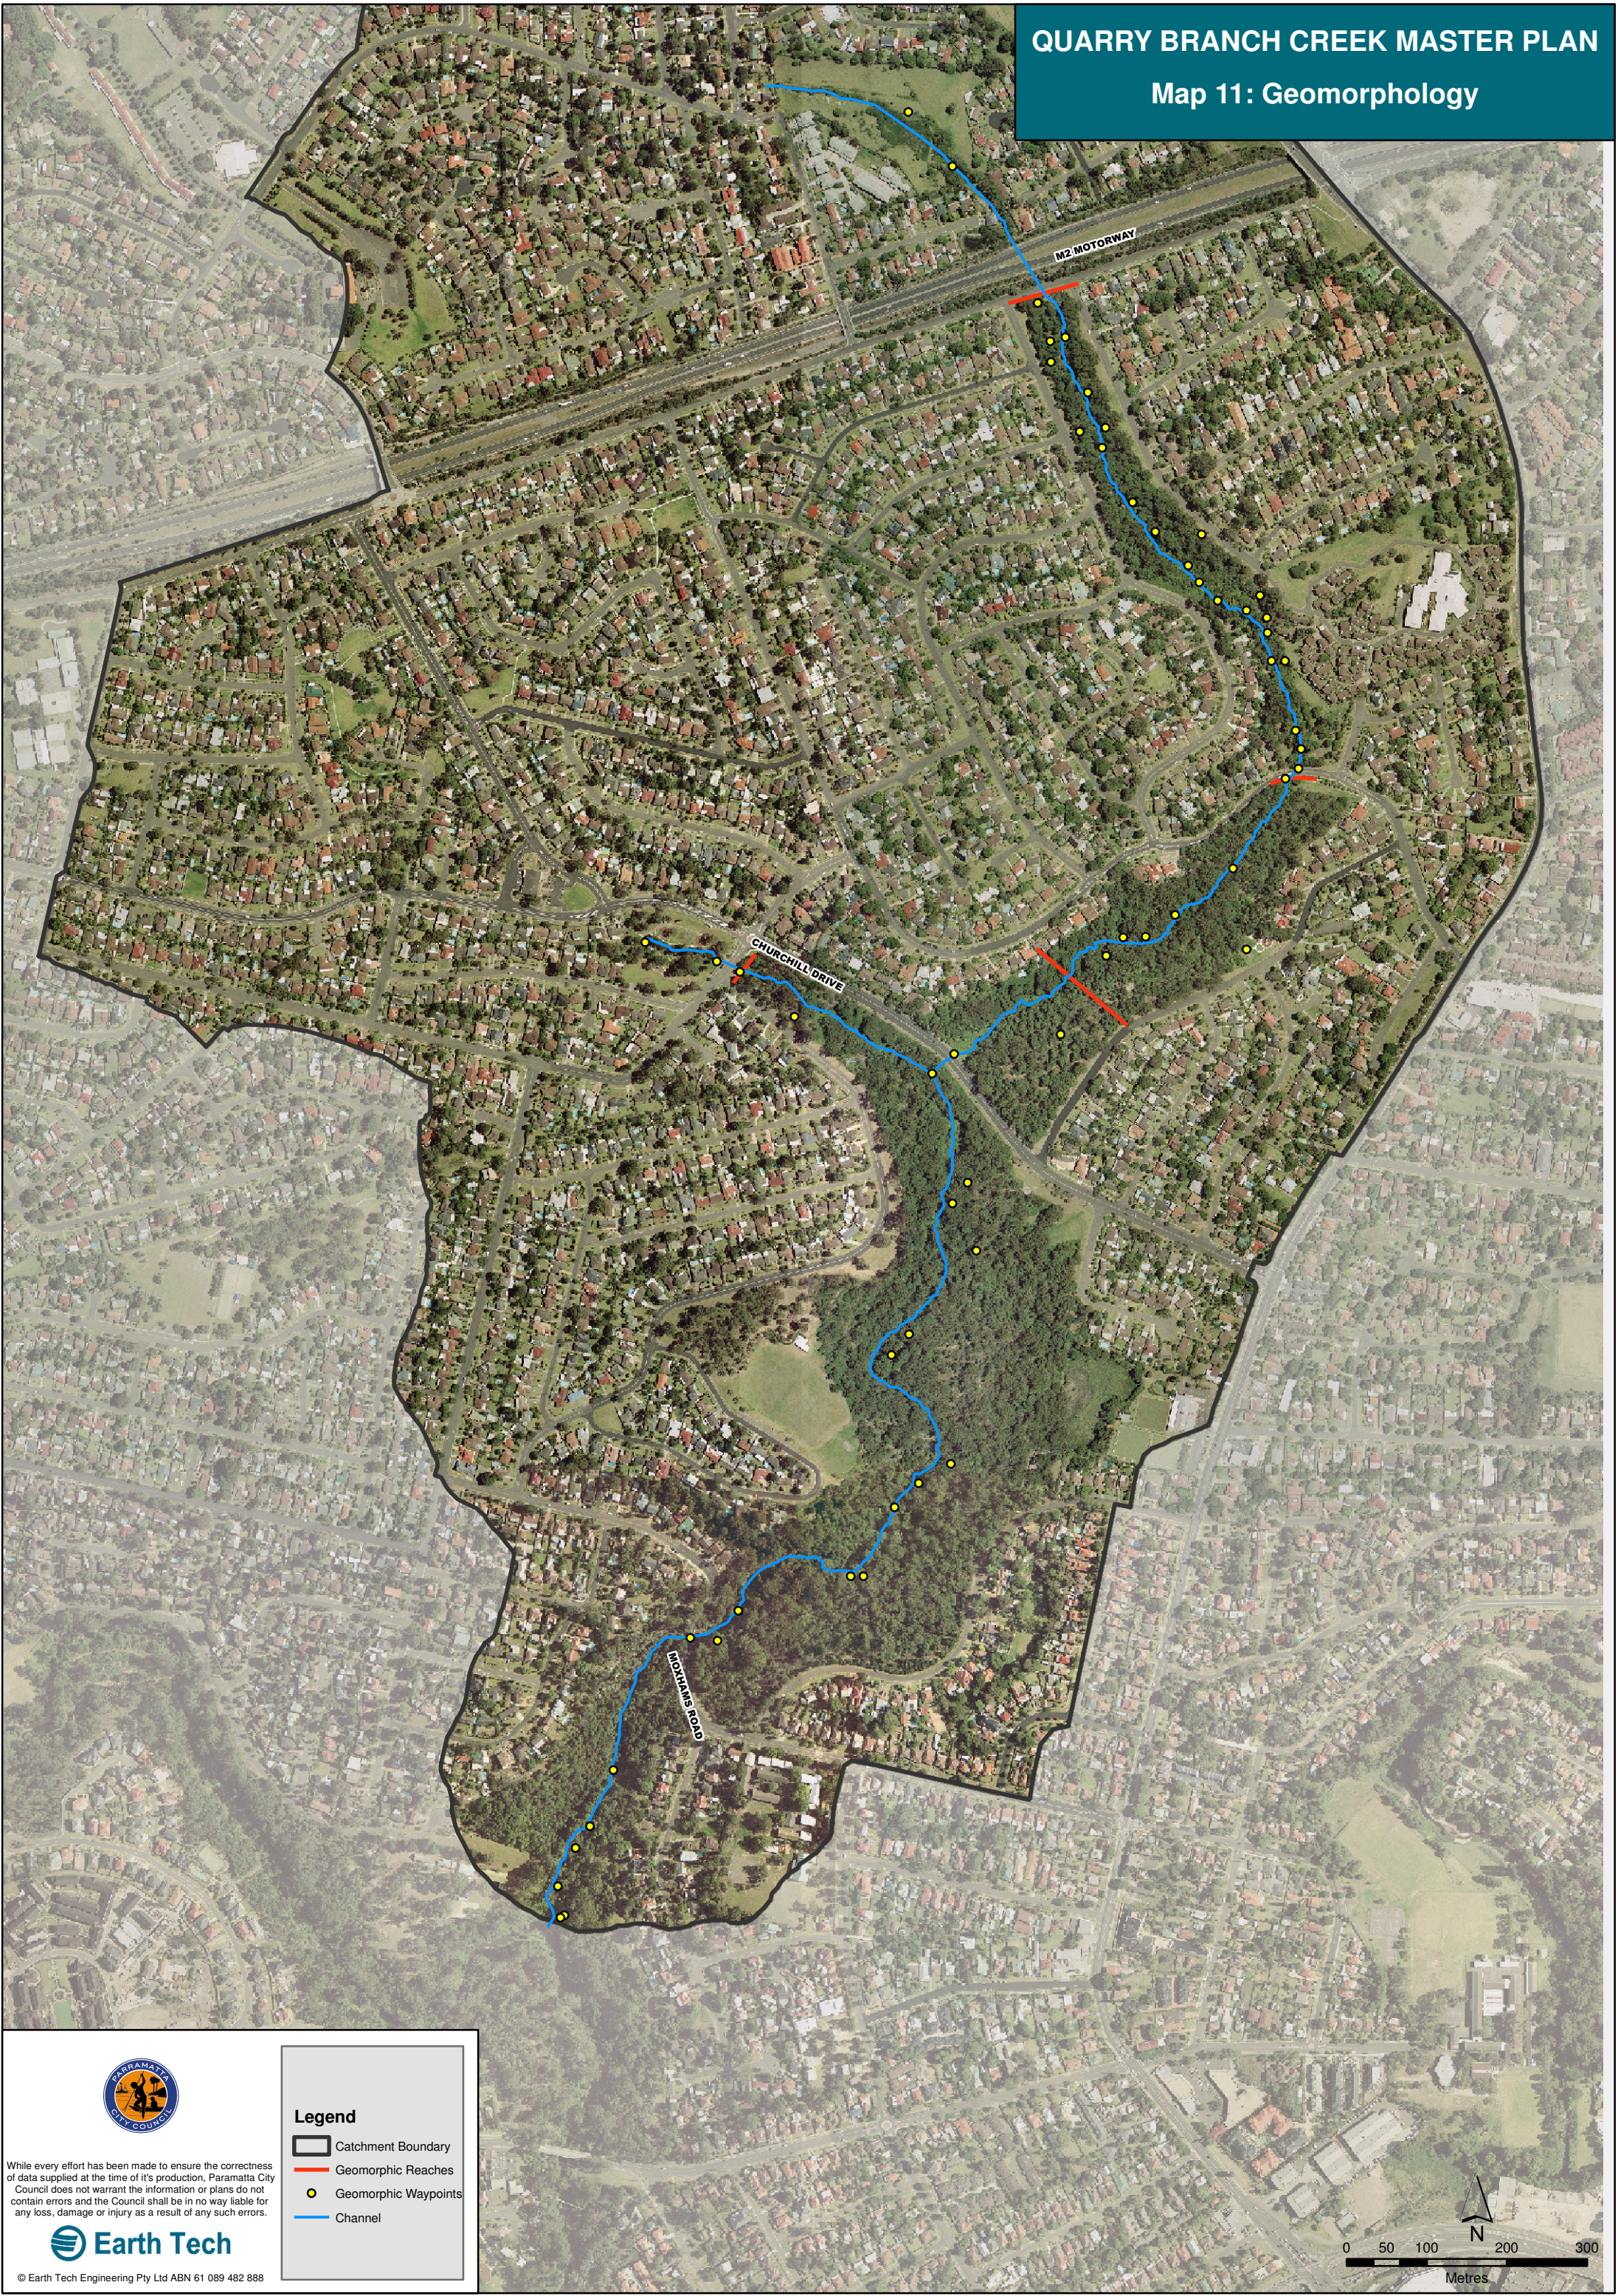
< Remove page and replace with **MAP 11 GEOMORPHIC REACH
BREAKDOWN** >

Geomorphically, Quarry Branch Creek channel and floodplain are stable and in good condition. Although there are small isolated pockets of instability and erosion extant in the channel zone, these do not present a threat to morphological stability or habitat. The substrate of the channel has a variety of grainsizes from sand to gravel and cobbles. At other locations bedrock sheets form the base of the channel and extend for many metres. Cross channel bedrock outcrops form bars and steps in the longitudinal profile that have led to the formation of significant plunge pools.

For a full morphological characterisation of Quarry Branch Creek refer to Appendix 15.

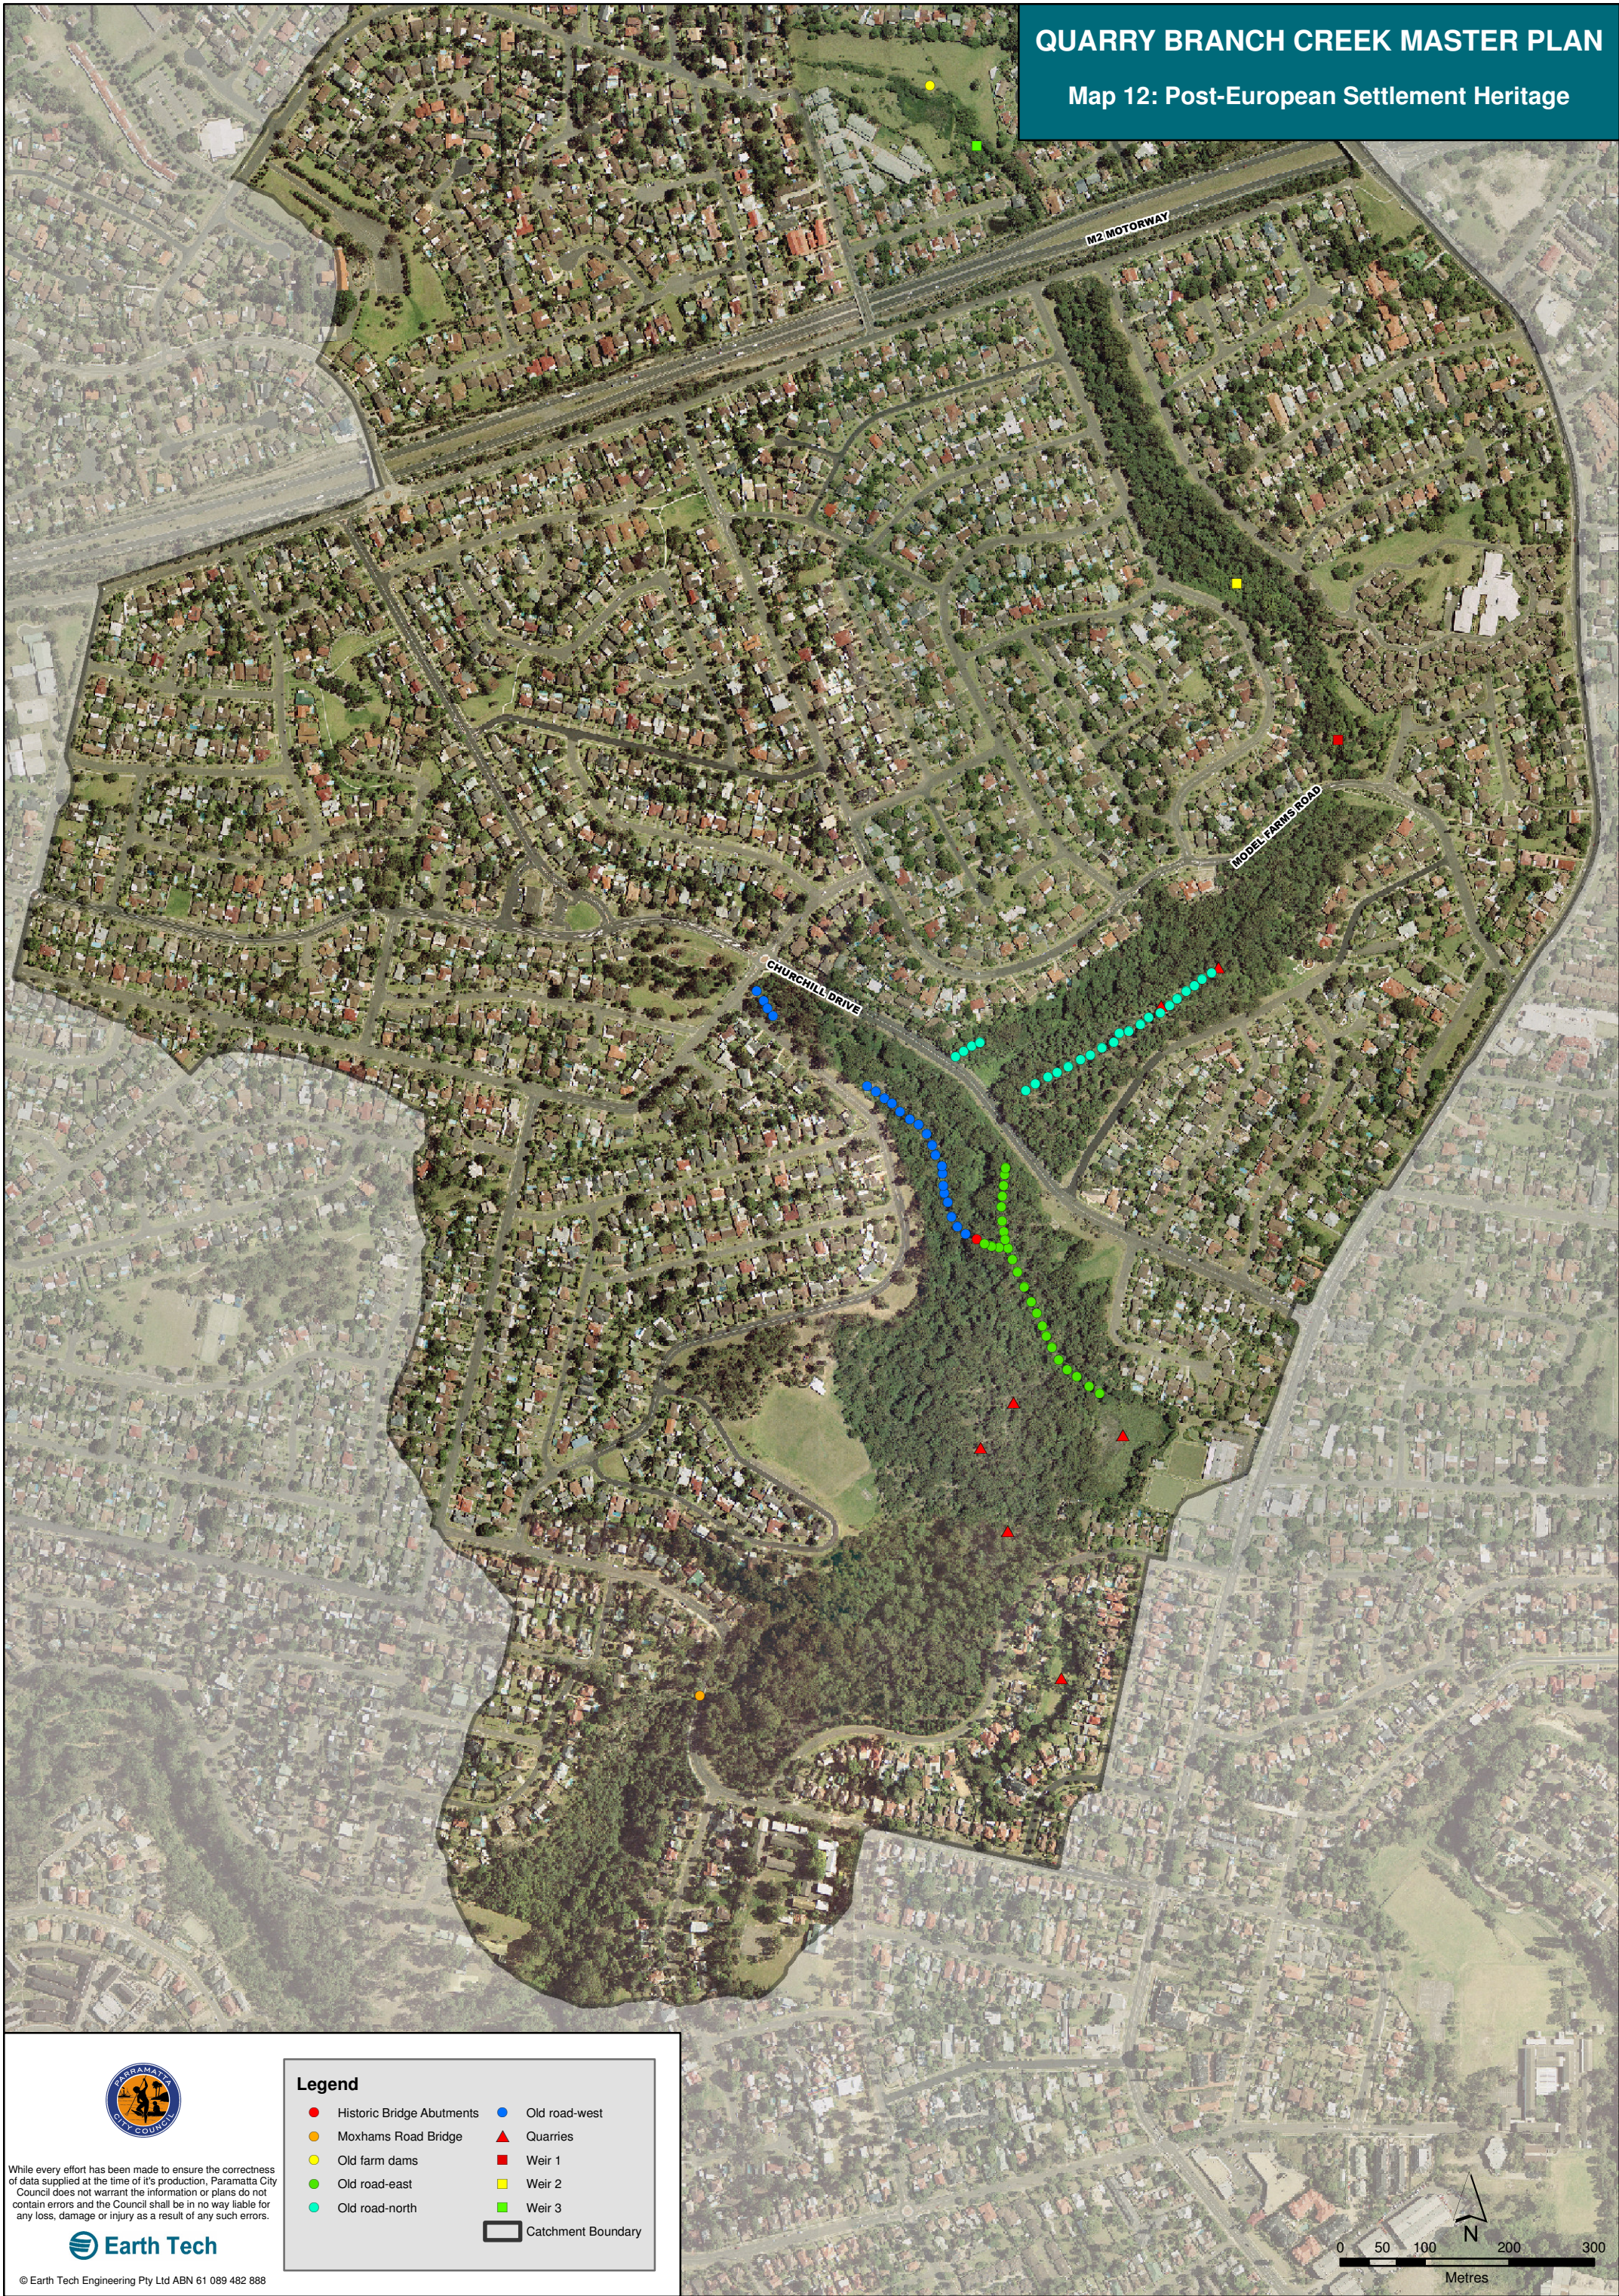
< Remove page and replace with MAP 12 - Post European Settlement Heritage Sites >

Table 8 – Locations of Heritage Items (also see map 12)

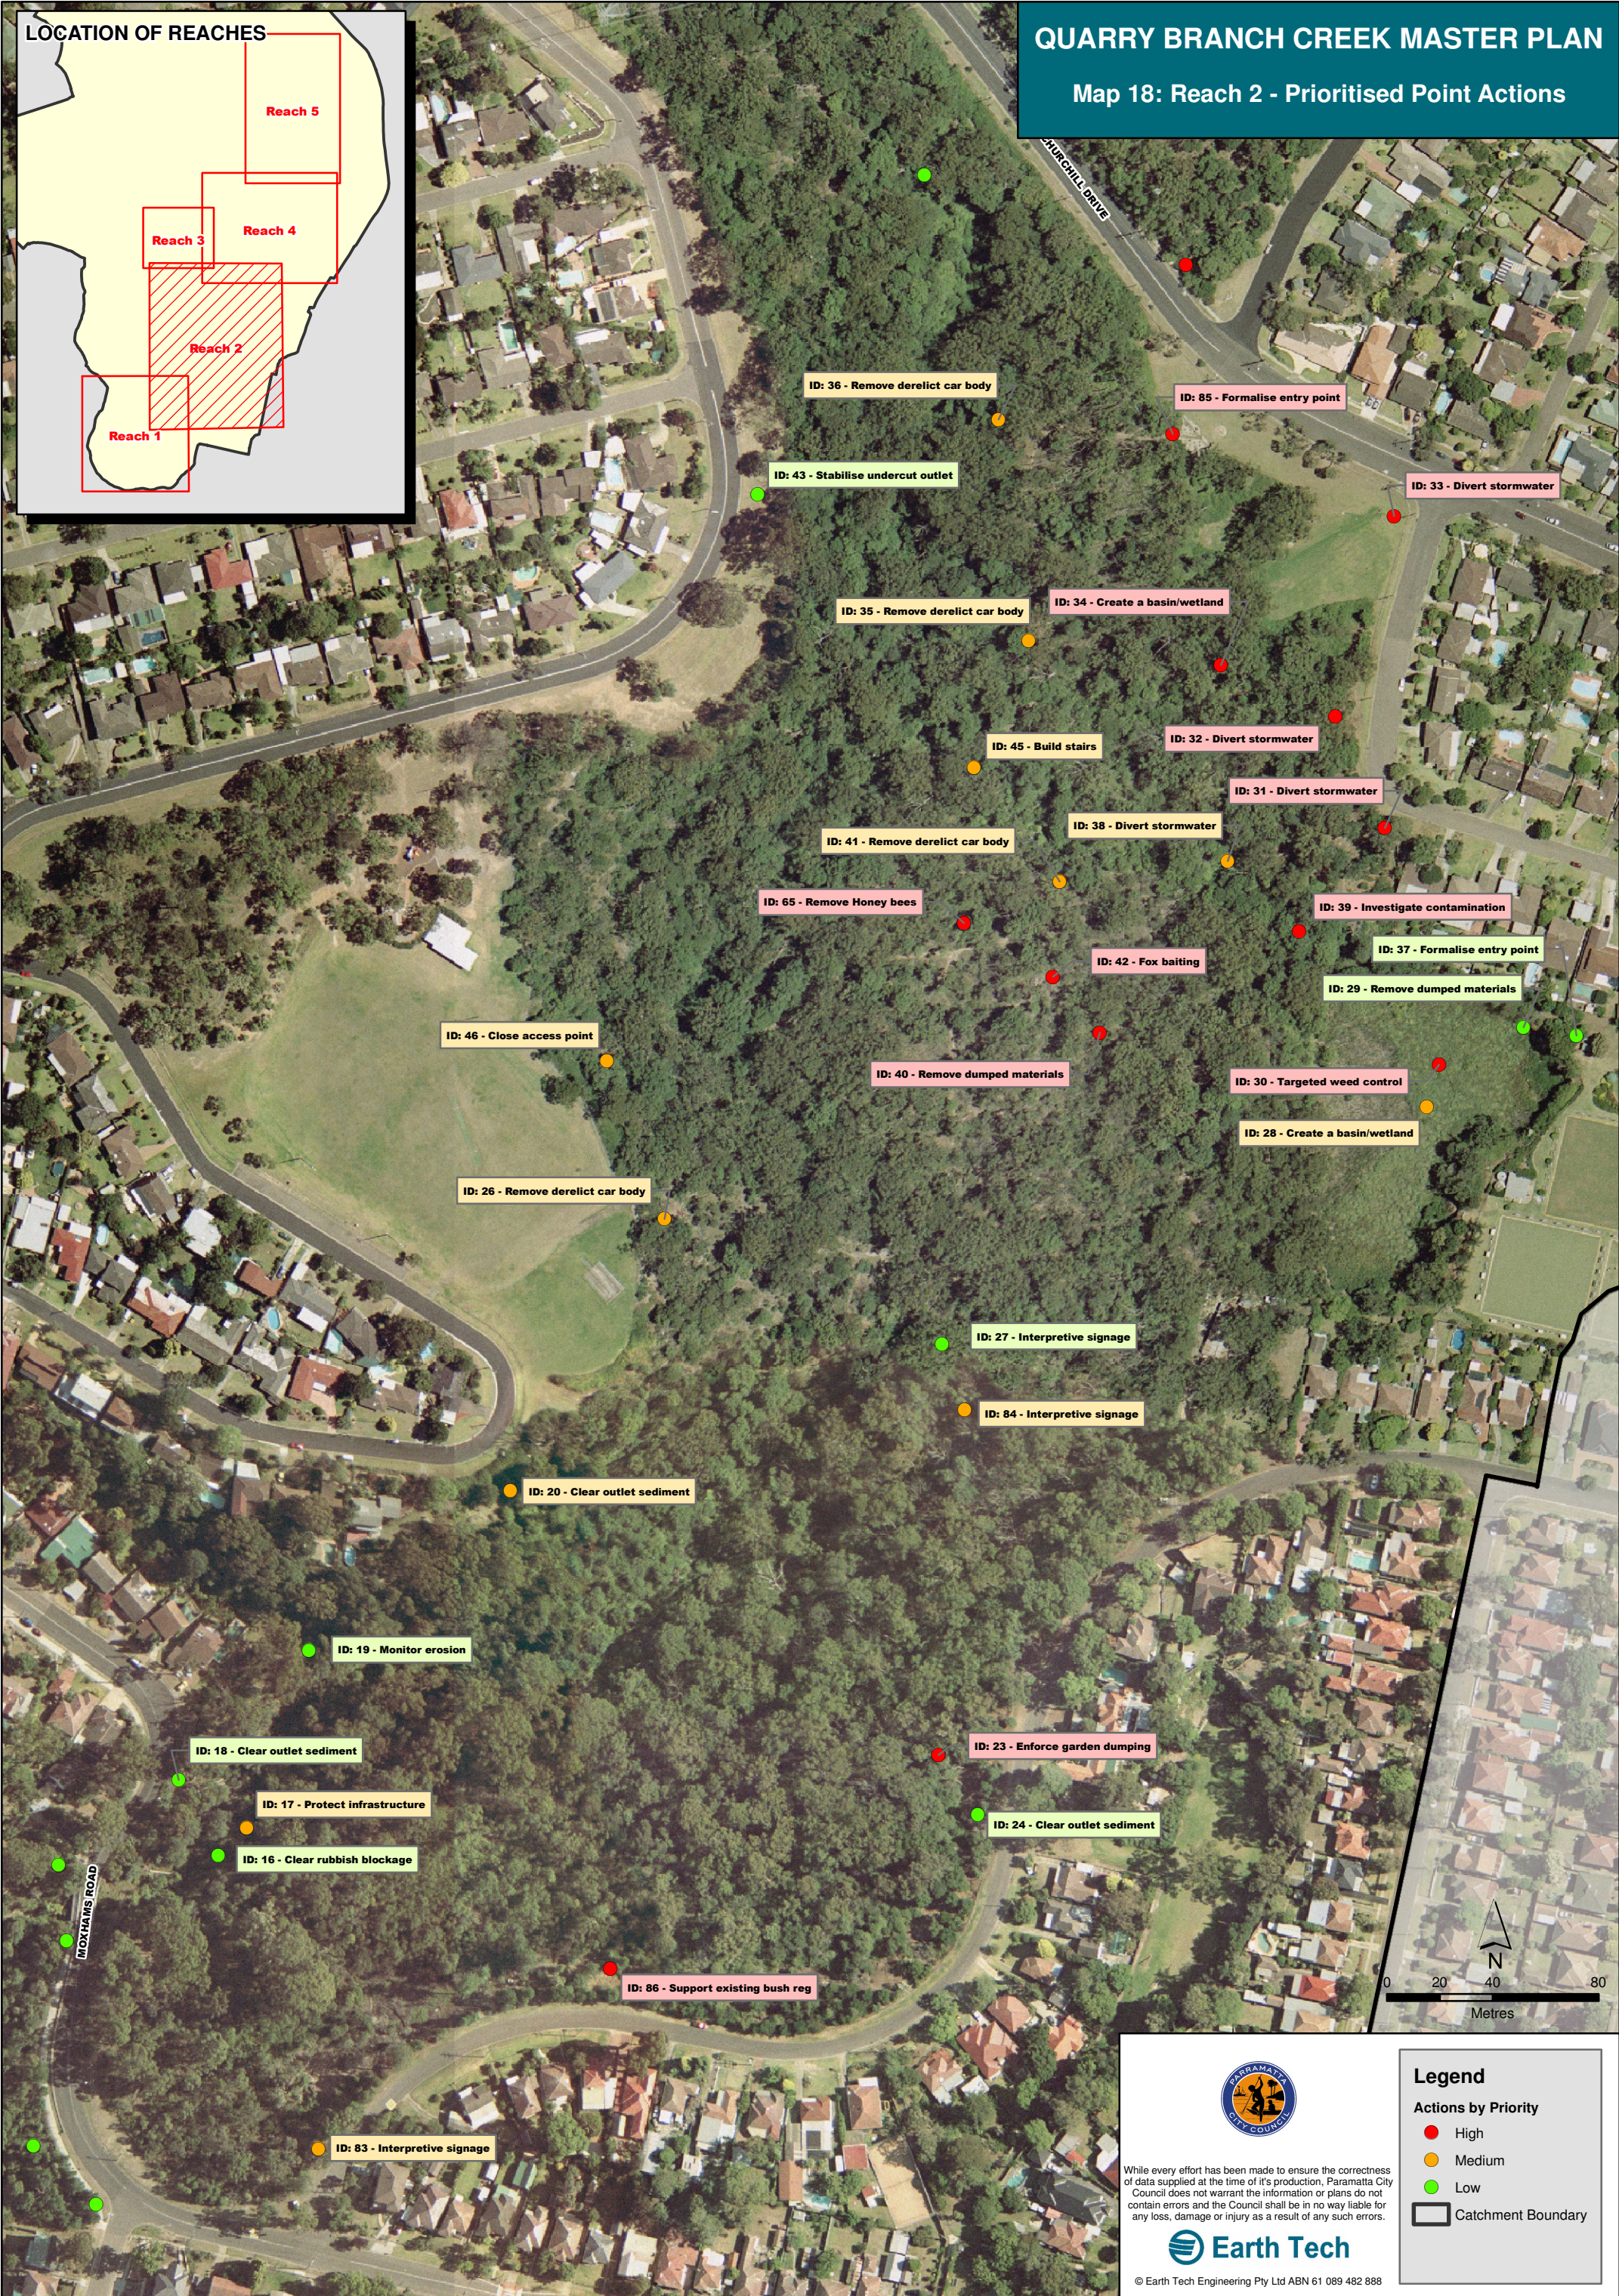
Map 18: Reach 2 - Prioritised Point Actions

U	39	D.3	<p>Investigate contamination</p> <p>Investigate and suitably remove of anthropogenic materials causing adverse risk or contamination to the groundwater and watercourse using appropriate methods.</p>
U	40	D.1	<p>Remove dumped materials</p> <p>Remove dumped domestic goods such as lounges, whitegoods to increase the social amenity for the community and install appropriate temporary signage highlighting fines associated with such activities.</p>
U	42	V.7	<p>Fox baiting</p> <p>Baiting of foxes within urban corridors is a common management technique to decrease fox predation of significance fauna species while also acting as a catalyst for domestic dogs to be leashed at all times.</p>
H	31	S.8	<p>Divert stormwater</p>
