# DETAILED MAPPING OF THE DUCK RIVER CATCHMENT

Prepared for Parramatta City Council

By Applied Ecology Pty Ltd

Project Title	DUCK RIVER CATCHMENT WATERWAYS MAINTENANCE AND REHABILITATION MASTER PLAN
Document Title	PRELIMINARY ASSESSMENT OF THE DUCK RIVER CATCHMENT WATERWAYS
Client	Parramatta City Council
Client contact	Pino Todarello

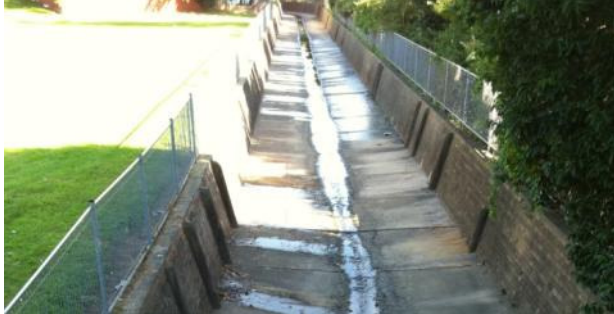
CHANNEL CONDITION	EXAMPLE
Concrete Lined  Example: Duck Creek 2 (pictured)

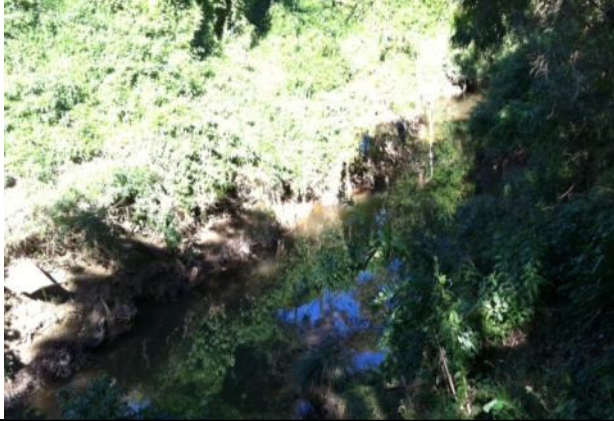
Moderately Eroding: Stream is incised and contained, regular bank undercutting and evidence of scour  Example: Duck River bank erosion in Reach 1 (Pictured)

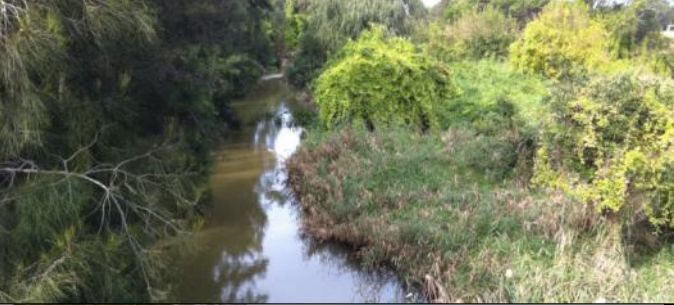
CHANNEL CONDITION	EXAMPLE
Stable: Few or no signs of bed and bank erosion, vegetated floodplain  Example: Duck River Reach 4 (Pictured)

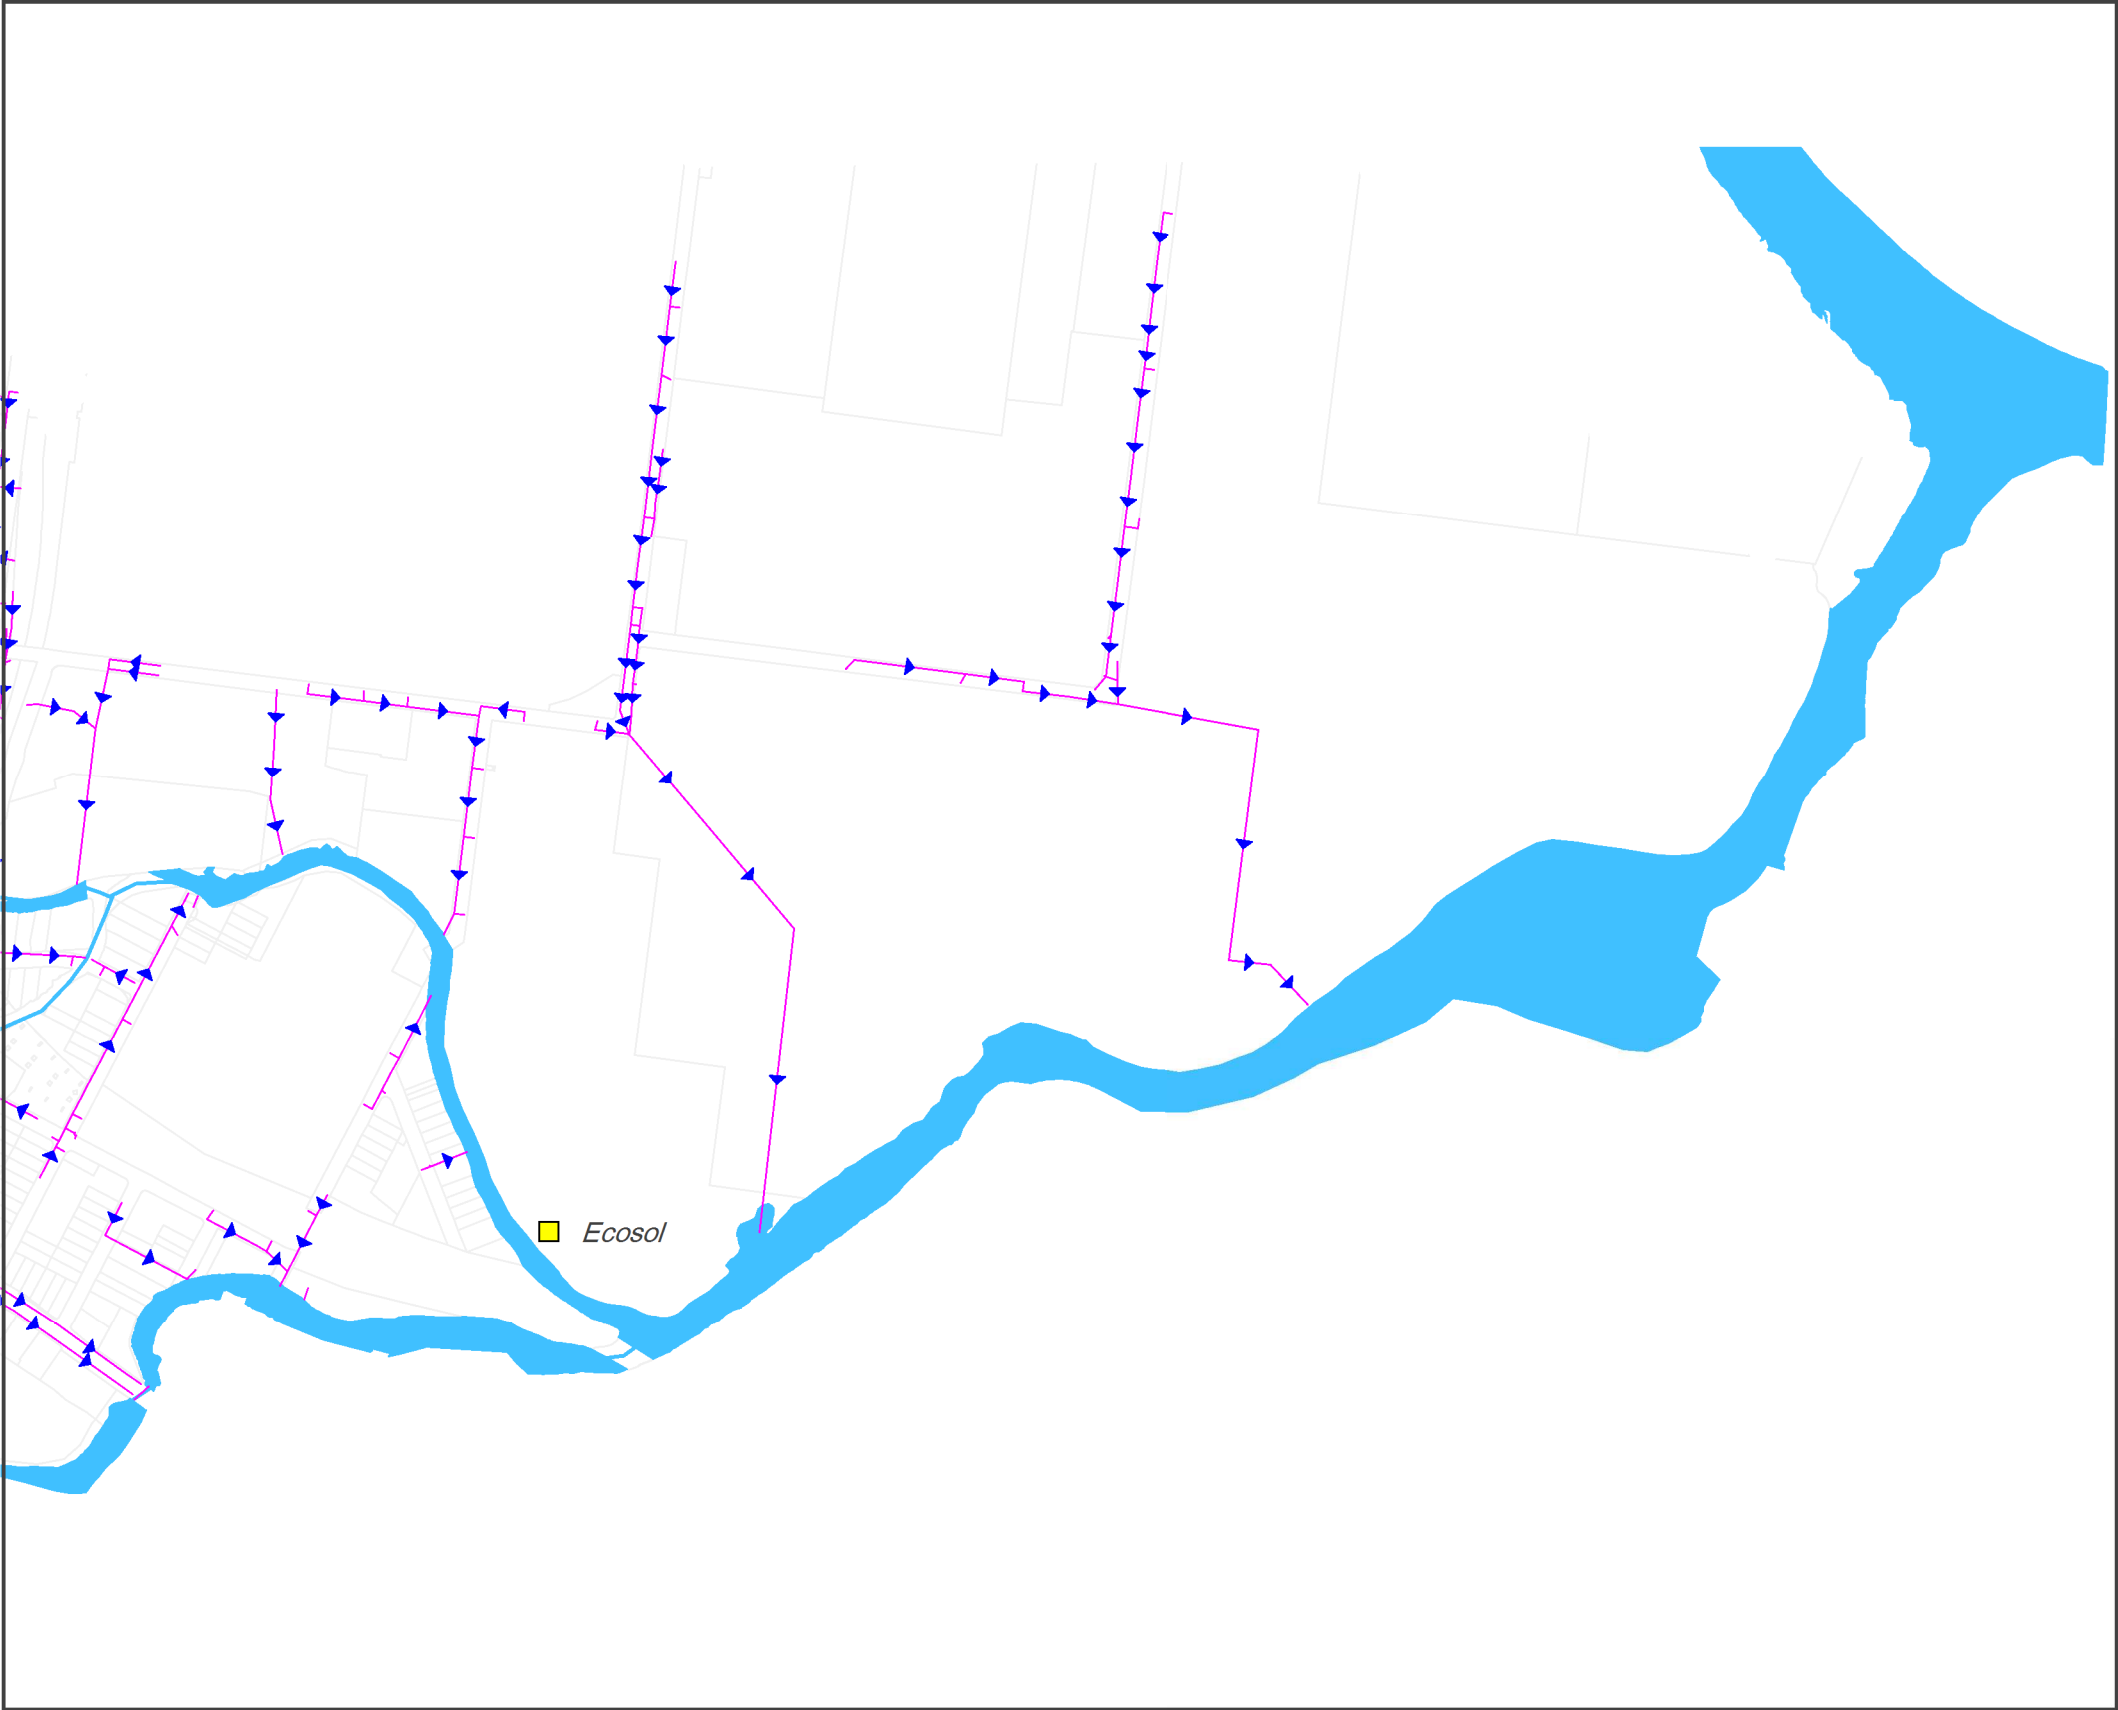
# PIPE NETWORK, GPTS AND WEIRS - DUCK RIVER CATCHMENT PARRAMATTA LGA

6	PIPE NETWORK, GPTS AND WEIRS- DUCK RIVER CATCHMENT PARRAMATTA LGA	3	Pipe network and outlets to watercourses and any stormwater improvement devices noted and any other obstructions noted. This data is potentially incomplete due to the concealed nature of many GPTs ( such as CDS units)	Field observations Cadastre-PCC Watercourses-PCC Pipe network-PCC
7	VEGETATION COMMUNITIES DUCK RIVER CATCHMENT PARRAMATTA LGA	3	Vegetation communities are represented by polygons.	Cadastre-PCC Watercourses-PCC Vegetation (Draft) : SMCMA
8	BUSHCARE/CONTRACT WORK SITES DUCK RIVER MAIN CHANNEL PARRAMATTA LGA	3	Bushcare and contract work sites as polygons overlaid on extant vegetation to provide context of current and past works (2008-)	Conversion of hard data provided by PCC Cadastre-PCC Watercourses-PCC Vegetation (Draft) : SMCMA
9	LAND USE DUCK RIVER CATCHMENT PARRAMATTA LGA	3	Key land use categories for each minor subcatchments adjoining open watercourses are represented graphically as % of subcatchment area	Subcatchments: SMCMA: - DR_XpRafts_SubCats Cadastre-PCC Watercourses-PCC
